US 20180291799A1

A repair kit and associated method for repairing an auto-
motive coolant pipe for fluid-conducting within an engine
block of an engine includes at least a repair stent, sealant and
instructions for performing the method. The repair stent may
be a whole tube, or a hollow semi-cylinder defining a gap.
The method includes draining coolant from the engine,
removing the water pump from the engine without removing
the timing chain cover of the engine, inserting the repair
stent including a sealant through the coolant passage,
wherein the coolant passage extends through the timing
chain cover into the engine, re-assembling the water pump
to the engine and adding coolant to the engine.

AUTOMOTIVE ENGINE COOLANT PIPE REPAIR APPARATUS AND METHOD

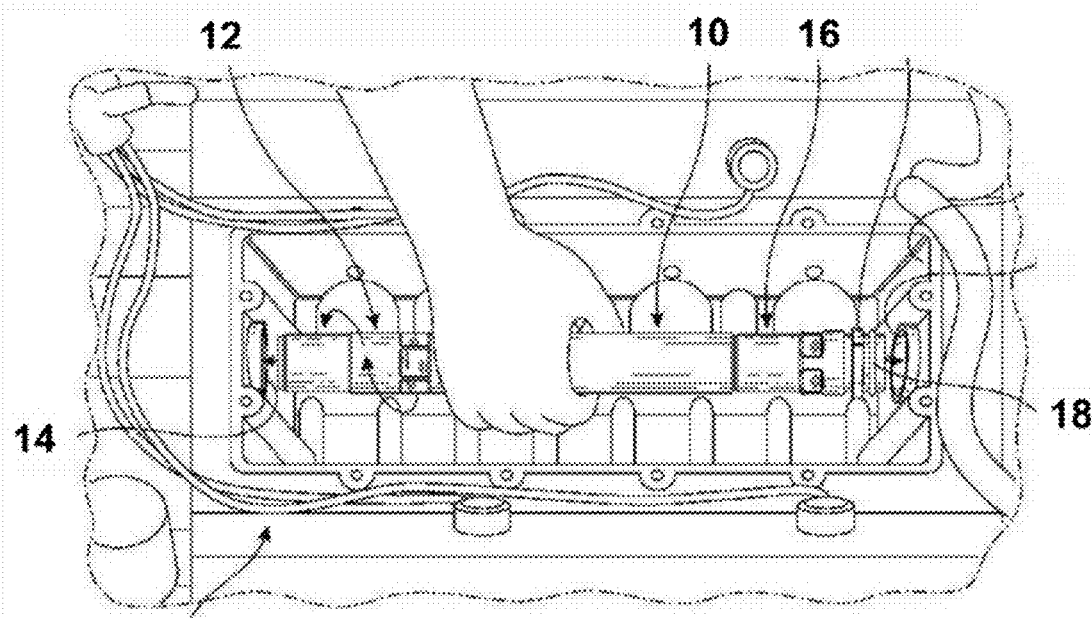
Fig. 1
(Prior Art)

[0010] FIGS. 1 and 2 show a replacement coolant transfer pipe **10** that is marketed by All German Auto as “the expanding cooling pipe,” in accordance with the disclosure in U.S. Pat. No. 8,464,424. The expanding cooling pipe is shown as being installed in the engine block of a BMW automobile having an N62 engine. Installation of the replacement coolant transfer pipe **10** is similar to that of the installation method for the collapsible BMW coolant transfer pipe, described above. Installation of the replacement coolant transfer pipe **10** also requires the removal of the intake manifold, and then requires cutting out the old coolant transfer pipe inside the engine block before the replacement coolant transfer pipe **10** can be installed.

[0011] However, unlike the BMW coolant transfer pipe, which is a two-piece ensemble, the expanding cooling pipe **10** is a single expandable pipe. The expanding cooling pipe **10** comprises a front tube **12** having: (i) a proximal portion configured for at least partially slidably and sealably engag-

ing a front sealing ring **14** seated within a front opening of the engine block, and (ii) a rear tube **16** telescopically engaged with the front tube **12**. The expanding cooling pipe **10** has a distal portion configured for at least partially slidably seating within a rear opening **18** of the engine block, whereby expansion of the cooling pipe apparatus within the engine block seats the proximal and distal portions of the front and rear tubes within the respective front and rear openings of the engine block. This feature provides sliding and rotational resistance to thereby stabilize the installation of the cooling pipe apparatus within the engine block.

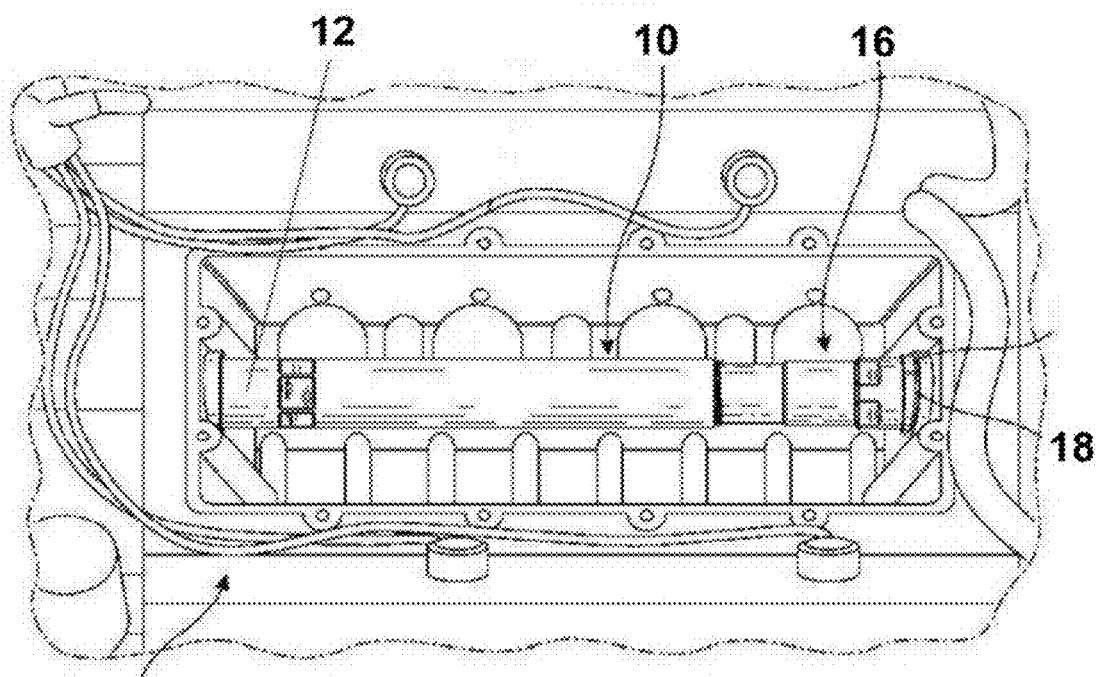
Fig. 2
(Prior Art)

[0022] FIG. 2 shows the expanding cooling pipe of FIG. 1 installed in the engine block;

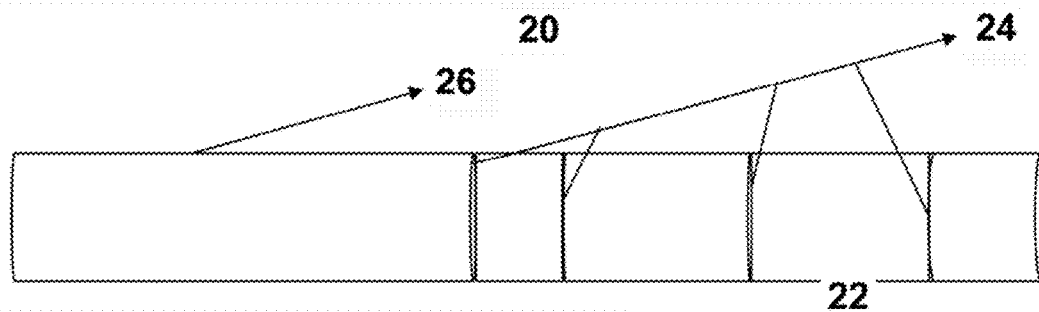
Fig. 3A

[0012] Bavarian Motor Parts (BMP) markets its own in-house designed collapsible BMW coolant transfer pipe **20** (Part No. 107914) as illustrated in FIGS. 3A-3E. This is a two-piece ensemble that contains; (i) a front inner tube **22** provided with machined o-ring grooves **24** on the outer surface to be fitted with seals and (ii) a rear outer tube **26**. The rear outer tube **26** has an inner diameter larger than or equal to the outer diameter of the front inner tube. The rear outer tube **26** also has a hollow protrusion **28** at one end whose outer diameter is smaller than the inner diameter of the front inner tube **22**. The outer tube **26** is fitted to the inner tube **22** by rotating the protruding part **28** of the outer tube **26** into the inner tube **22**. The fitting is packed with a nylon angled packing piece **30** to achieve a tight fit. The ends of the resultant pipe are then fitted to the corresponding receptacles **14**, **18** in the engine block.

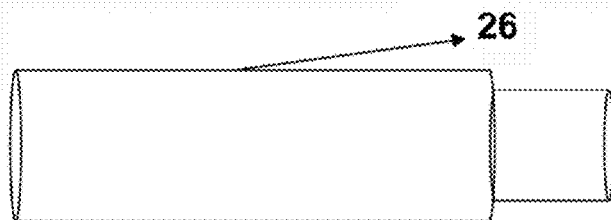
Fig. 3B

[0023] FIGS. 3A-3E illustrate components provided in a BMP Design Collapsible BMW Coolant Transfer Pipe kit, in accordance with the prior art;

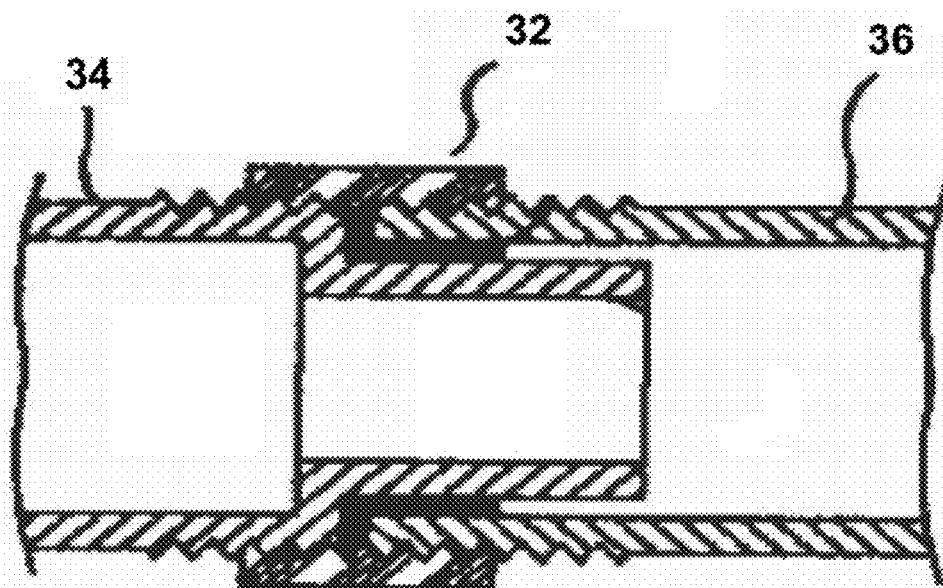
Fig. 4
(Prior Art)

[0014] Korean Patent publication KR 100143619 of Daewoo Motor Co. LTD., illustrated in FIG. 4, discloses a pipe fitting **32** wherein a projecting part of a first pipe **34** can be inserted into a second pipe **36**. The joined portion is coupled with the fitting **32** to prevent a coolant from leaking through the gap between the first pipe **34** and the second pipe **36**. However, this arrangement involves a plurality of parts and is only as good as the integrity of the coupling. Compression and expansion can affect the integrity of the coupling. Also, such an arrangement cannot prevent coolant leakage at the front seal.

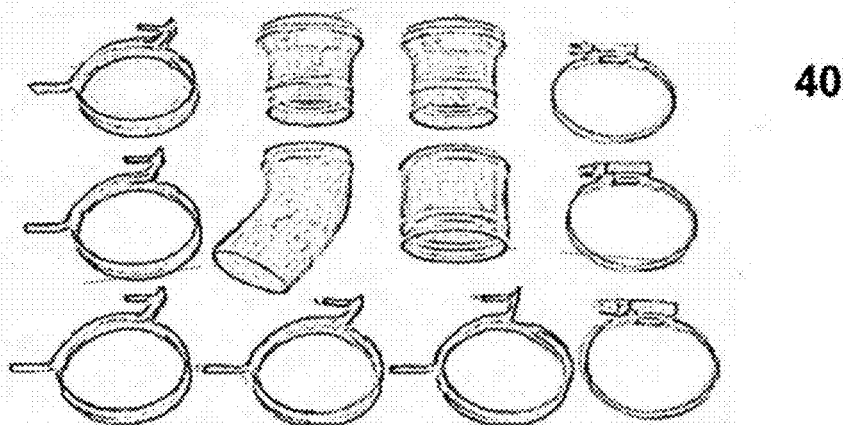
Fig. 5
(Prior Art)

[0015] A GoWesty coolant pipe repair kit, illustrated in FIG. 5, provides a collection **40** of Brass fittings, screw clamps and spring clamps. However, these are suited only for repairing radiator coolant pipes located outside the engine block in Vanagons.

[0025] FIG. 5 is an illustration of components of a coolant pipe repair kit available from GoWesty, in accordance with the prior art;

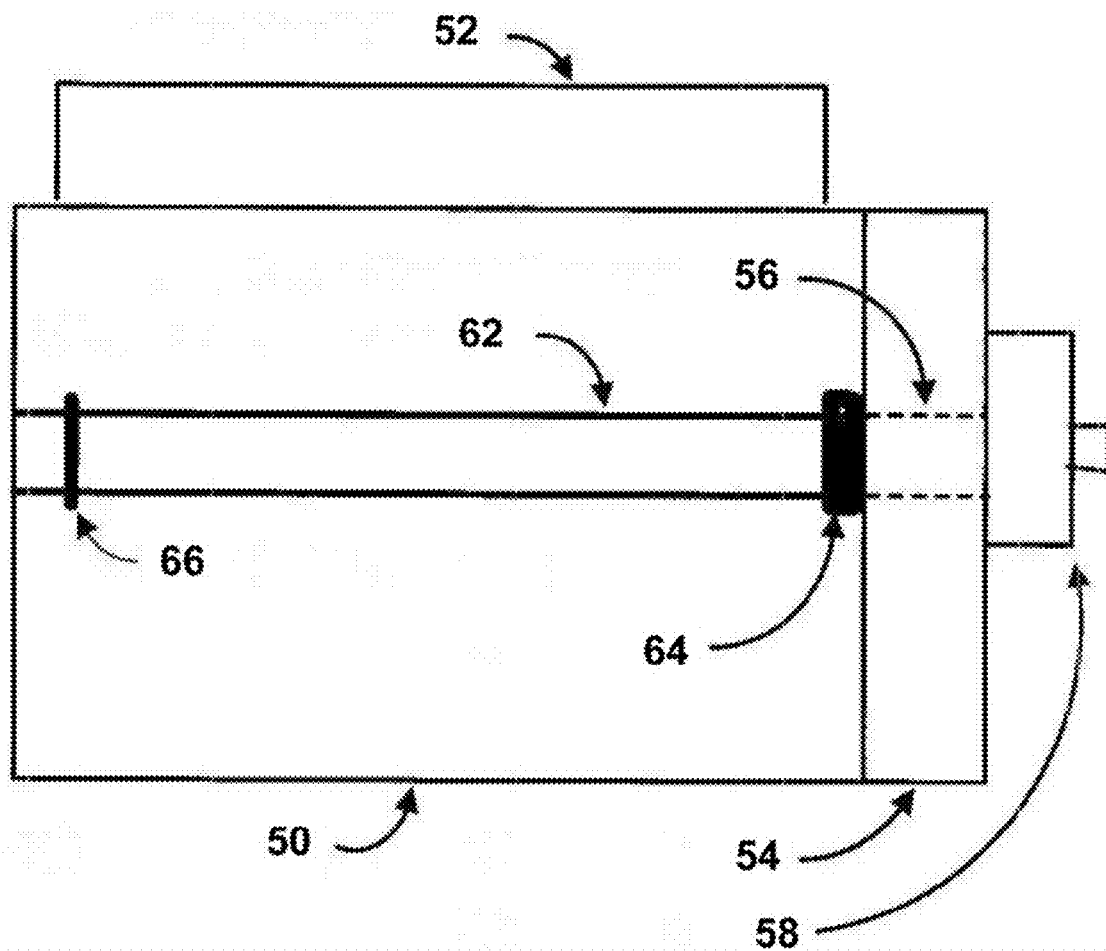
Fig. 6
(Prior Art)

[0026] FIG. 6 is a cross sectional view of a conventional engine block, in accordance with the prior art;

[0039] FIG. 6 shows the side view of a crosscut section of a typical engine block 50. This drawing illustrates a typical configuration for a BMW "N62" engine, but other engine configurations will still be within the teachings of this apparatus and method disclosure herein. During normal engine operation, the water pump 58 pumps coolant through the engine block 50, first from the water pump 58, through

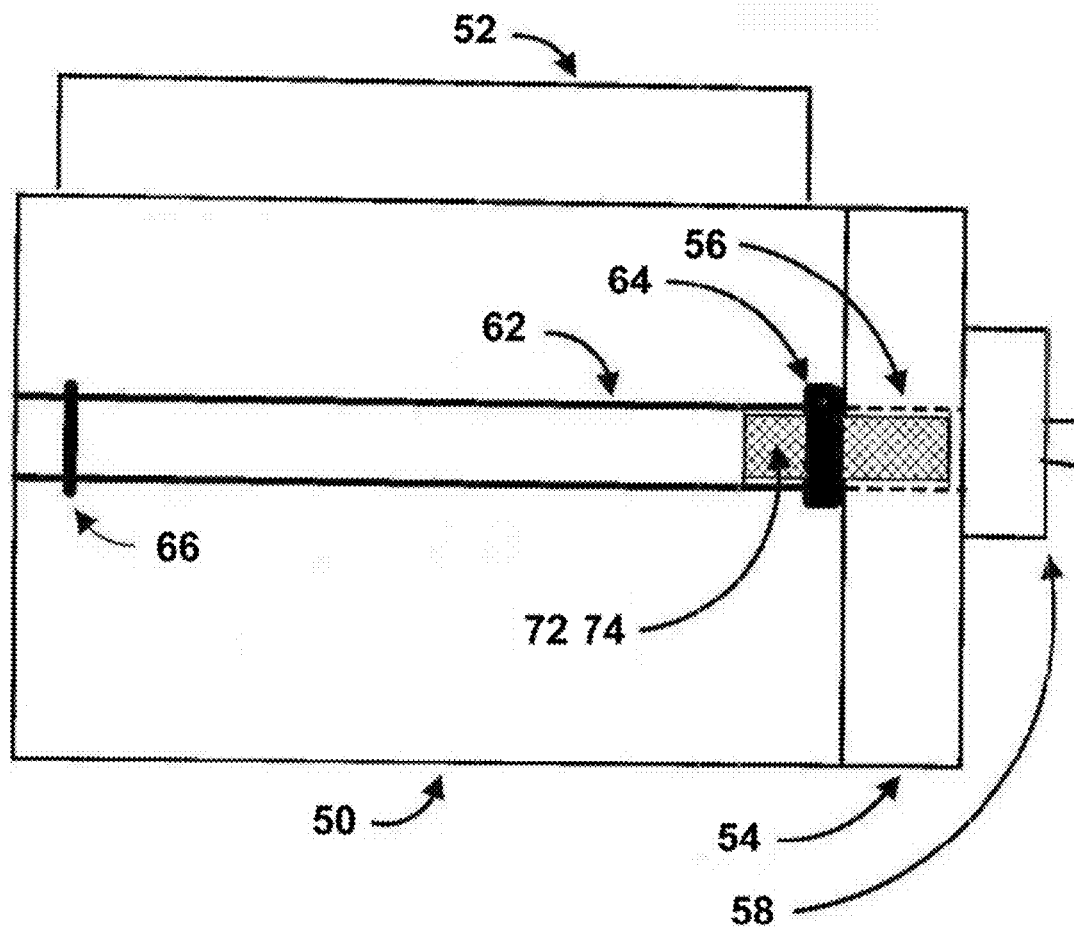
Fig. 7

[0027] FIG. 7 is a view of the conventional engine block of FIG. 6 illustrating an apparatus and method for repairing a leaking front seal and coolant transfer pipe, in accordance with the present invention;

[0041] FIG. 7 shows a unique apparatus and method for repairing the leaking front seal 64 and coolant transfer pipe 62, without the need to remove the intake manifold 52 or the timing cover 54, thereby saving many hours of expensive labor and costly parts and materials. After removing the water pump 58, a repair tube insert 72 may be coated with sealant 74 and inserted through the timing cover coolant passage 56 directly into the coolant transfer pipe 62.

[0042] The repair tube insert 72 when coated with sealant 74 creates a bond and seal between the timing cover coolant passage 56, the coolant transfer pipe 62 and the front seal 64, in order to stop coolant from leaking into the engine block 50. The original front seal 64 and the coolant transfer pipe 62 do not need to be removed from the engine block 50, and remain in place.

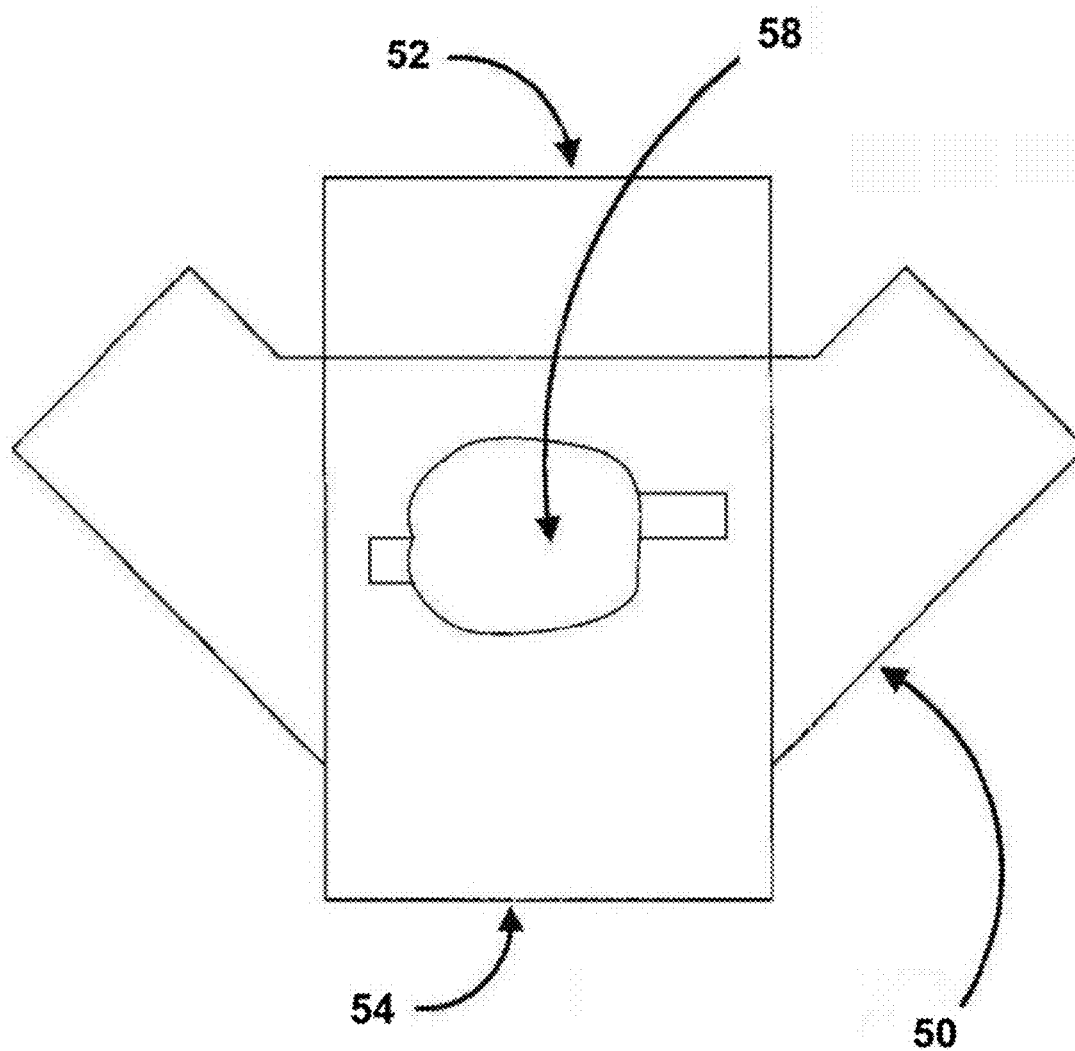
Fig. 8

[0028] FIG. 8 is a front view of the conventional engine block of FIG. 7 with a water pump installed, in accordance with the present invention;

[0043] FIG. 8 shown a front view of a typical vehicle engine with a water pump 58, an intake manifold 52, a timing cover 54 and engine block 50. FIG. 9 shows the vehicle engine of FIG. 8 with the water pump 58 removed to provide access to the timing cover coolant passage 56. This access makes it possible to clean the inside walls of the timing cover coolant passage 56 and, as shown in FIG. 7, the front seal 64 and the coolant transfer pipe 62.

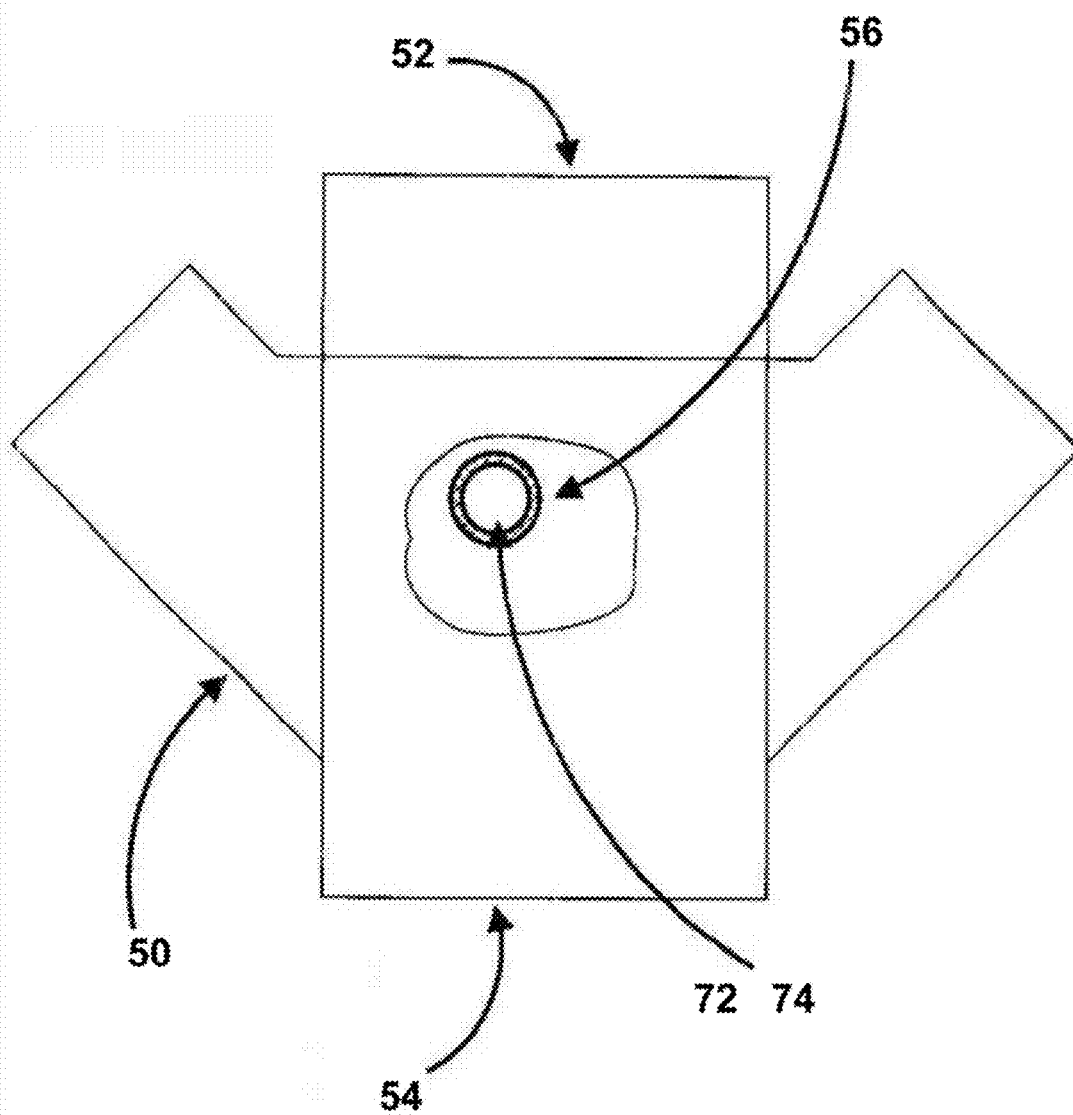
Fig. 9

[0029] FIG. 9 is a front view of the conventional engine block of FIG. 7 with the water pump removed;

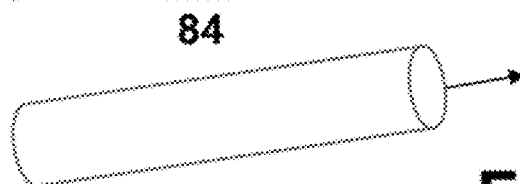
Fig. 10B

Cleaning Rod

[0030] FIGS. 10A-10C illustrate repair kit components, including a sanding rod, a cleaning rod and a sponge applicator brush, in accordance with the present invention; and

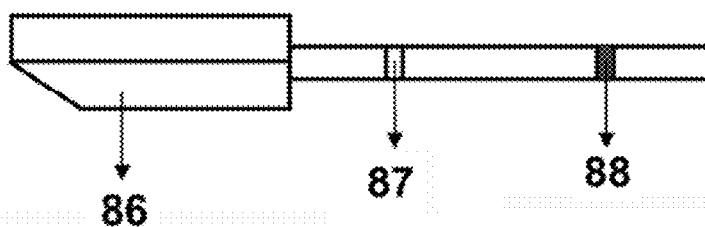
Fig. 10C

Sponge Applicator Brush

- [0099] 26. Applying the coolant pipe repair sealant to a sponge applicator brush **86**. Coating the inside passage of the timing chain cover and coolant transfer pipe with

the coolant pipe repair sealant, ensuring that the sponge brush is not inserted past the “RED” mark **87** on the handle;

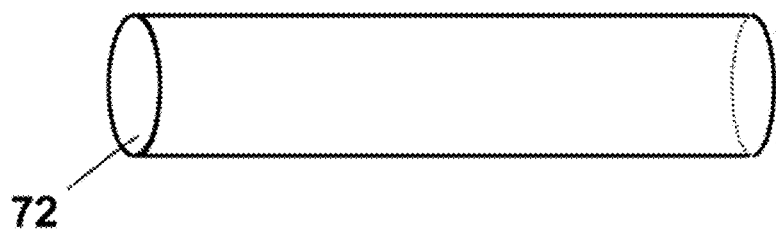
Fig. 11A

Repair Tube Insert (The Stent)

[0052] The sealant **74** may be a silicon-containing product or silicone based material, epoxy based material, petroleum based product, or any other material or gasket that will provide a watertight seal between the repair tube insert **72**, the coolant transfer pipe **62**, the front seal **64**, and the timing cover coolant passage **56**. The repair tube insert **72** or “stent **72**” of the preferred embodiment of the present invention is an open ended, hollow cylindrical tube with circular ends. FIG. 11A illustrates the structure of the stent **72**. In an

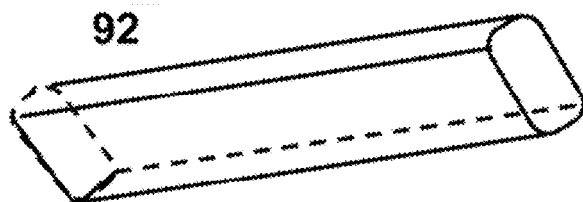
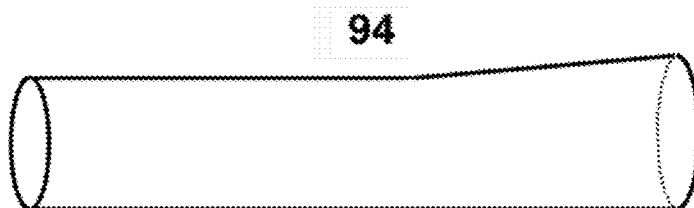
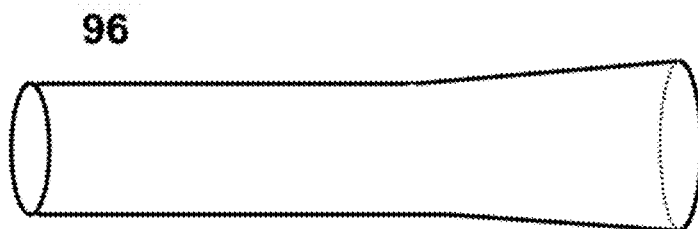
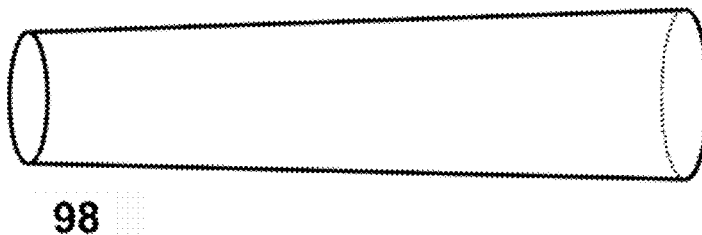
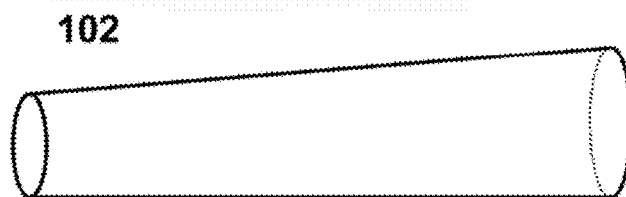
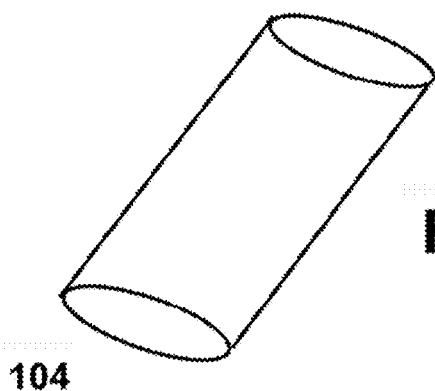
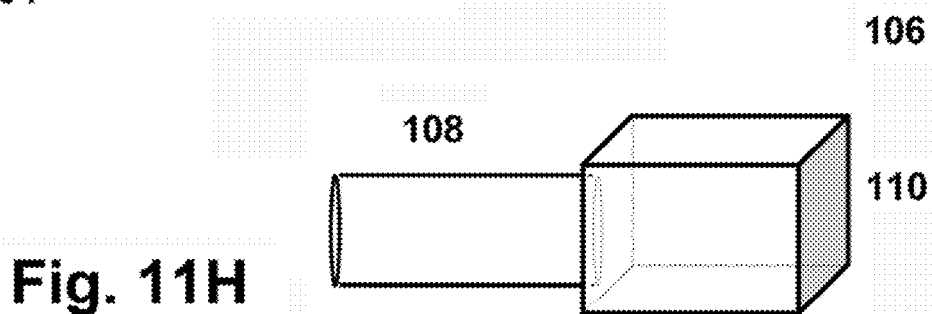
[0031] FIGS. 11A-11J illustrate various embodiments of repair tube inserts, in accordance with the present invention.

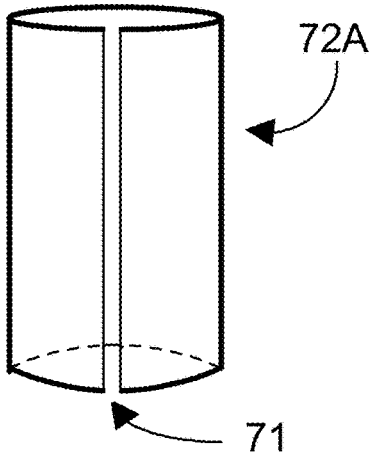
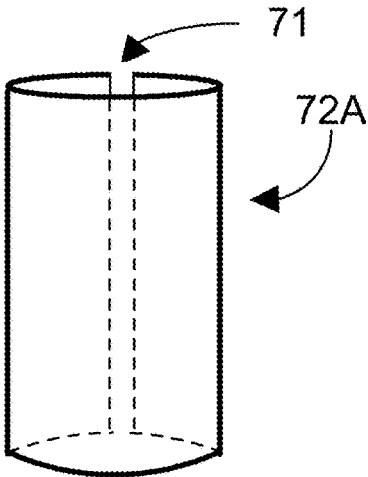
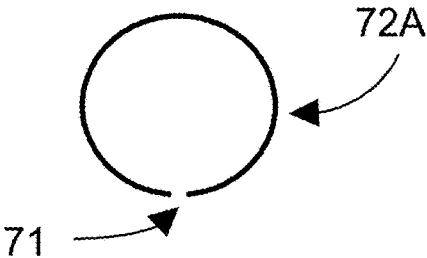
[0032] FIGS. 12A-12C are a front perspective view, a back perspective view and an end view, respectively, of a repair tube insert in accordance with another embodiment of the present invention.

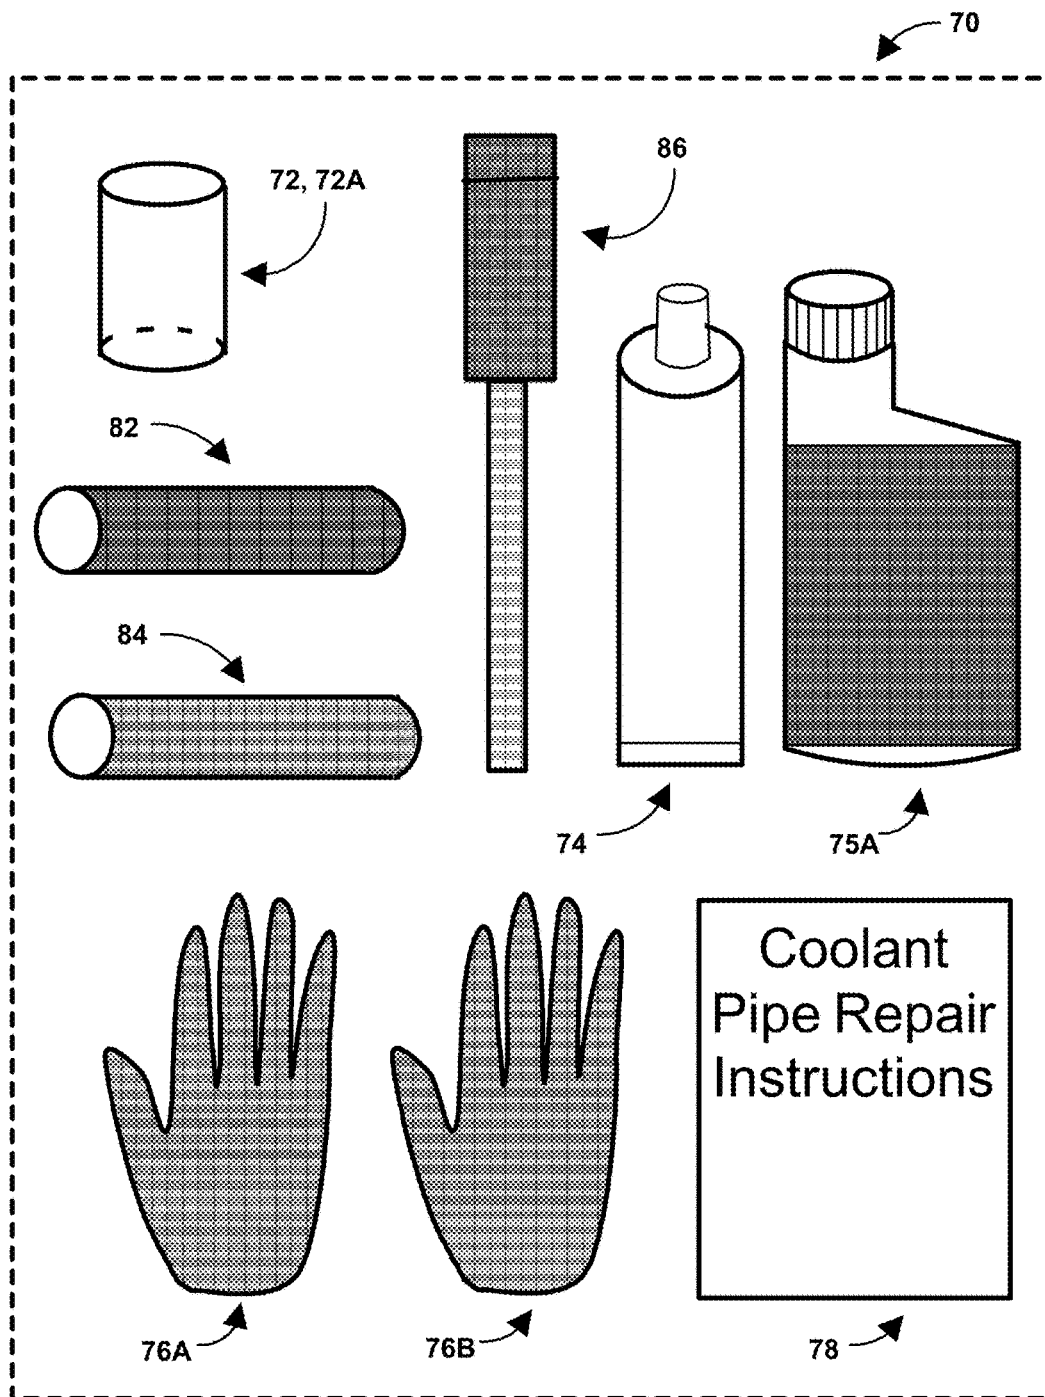
[0033] FIG. 13 illustrates a repair kit in accordance with yet another embodiment of the present invention.

[0049] The repair kit or apparatus disclosed herein is illustrated in FIG. 13 and comprises at least one open ended, hollow repair tube insert or stent **72** (or **72A** as described in further detail below), at least one cleaning rod **84**, at least one sanding rod **82**, one or more sponge applicator brushes **86**, at least one pair of rubber work gloves **76A**, pairs of disposable rubber gloves **76B**, at least one tube or pack of coolant pipe repair sealant **74A**, at least one bottle or jar of cooling system sealer/coolant pipe O-ring conditioner **75**, and detailed written instructions **78** with illustrations. The cooling system sealer/coolant pipe O-ring conditioner **75** are optional, as it is not necessarily required to achieve the objective of the present invention. The cooling system sealer and conditioner **75** is not required to stop the “weep hole” leak from the front seal on the coolant transfer pipe. The front seal leak is repaired by the stent **72**. However, cooling system sealer/coolant pipe O-ring conditioner **75**, is designed to condition the seals of the coolant transfer pipe, valley pan and gasket, as well as the gaskets of the rear coolant passage cover.
