(10) **Pub. No.: US 2021/0070472 A1**

(54) **CESSNA TAIL-CONE REINFORCEMENT ANGLE SPLICE, INSTALLATION KIT, AND METHOD FOR INSTALLATION THEREOF**

A tail-cone reinforcement angle of a Cessna 180-185 series aircraft is repaired by the removal of an aft most section of that tail-cone reinforcement angle and its replacement with an elongated splice body. The elongated splice body is attached to the remainder of the tail-cone reinforcement angle and to the tail-cone portion of the fuselage of the aircraft. The aft section of the original tail-cone reinforcement angle is subject to the development and propagation of cracks in the area of the rear pivot shaft receiving bore, which cracks render the aircraft unfit for use. The invention includes the provision of a suitable elongated splice body, a method for its installation, and a tool kit which is usable in accomplishing the removal and replacement of the aft section of the tail-cone reinforcement angle.

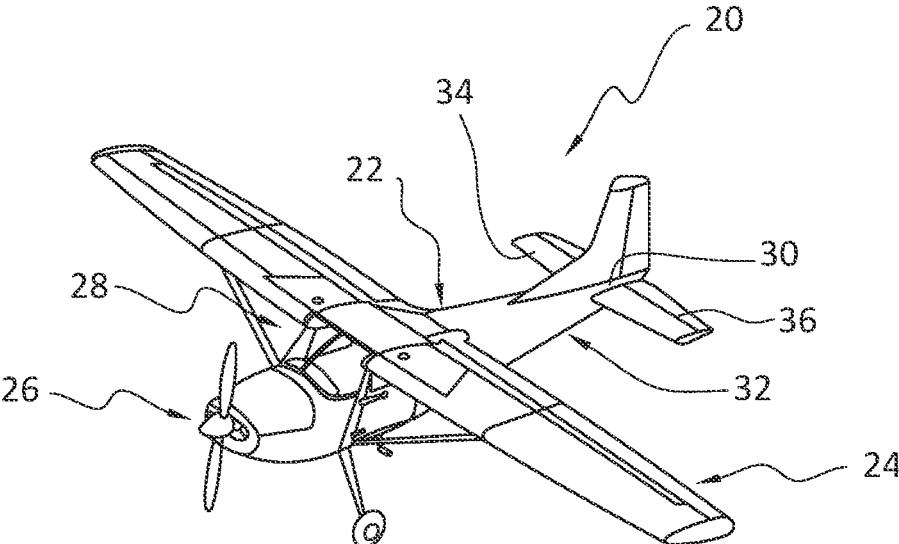
[0016] FIG. 1 is a schematic depiction of a Cessna series 180-185 series aircraft with which the pertinent invention is intended for use;

[0029] Referring initially to FIG. 1 of the patent drawings filed in the subject U.S. patent application, there may be seen, generally at **20**, a typical Cessna 180-185 series aircraft with which the tail-cone reinforcement angle splice, in accordance with the present invention, finds particular usage. Aircraft **20**, as is well known to one familiar with such aircraft, includes a fuselage, generally at **22**, forward upper mounted wings **24**, an engine and propeller assembly **26**, a cockpit **28** and a rear elevator and stabilizer assembly generally at **30**. The rear elevator and stabilizer assembly generally at **30**, is attached to a rear portion of the fuselage **22**, in an area that fuselage known as the tail-cone **32**, which tail-cone area **32** is seen somewhat schematically in FIG. 2. The rear stabilizer and elevator assembly, generally at **30**,

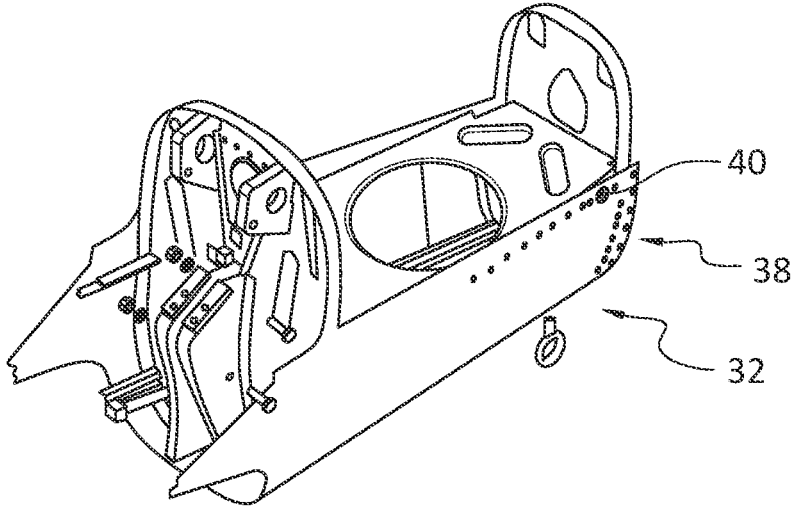
[0017] FIG. 2 is a schematic depiction of a tail-cone area of the Cessna 180-185 series aircraft depicted in FIG. 1, and with the horizontal stabilizer, elevator, tail, tail wheel and stinger removed;

[0042] Once the tail of the Cessna 180-185 series aircraft has been disassembled, to render the tail-cone assembly as it is depicted in FIG. 2, the installation process may commence. The initial step is to use a suitable reamer, which is supplied in a kit that is provided by the manufacturer of the subject invention, and which is supplied together with, and including the subject tail-cone reinforcement angle splice, as will be discussed subsequently, to ream out both the horizontal stabilizer rear pivot aperture 40 in the tail cone of the fuselage and the underlying bore 44 in the original far aft portion of the now defective tail-cone reinforcement angle. Once this has been accomplished, four aft flush rivets 82, in the tail cone portion 32 of the fuselage 22 and in the underlying blade portion 42 of the tail-cone reinforcement angle, are drilled out. This is depicted in FIG. 9 of the drawings accompanying the application. The holes in the web of the blade portion of the tail-cone reinforcement angle, which result from the drilling out of these four flush rivets 82, will align with the rivet receiving holes 68 in the forward or overlap section 62 of the splice 54.

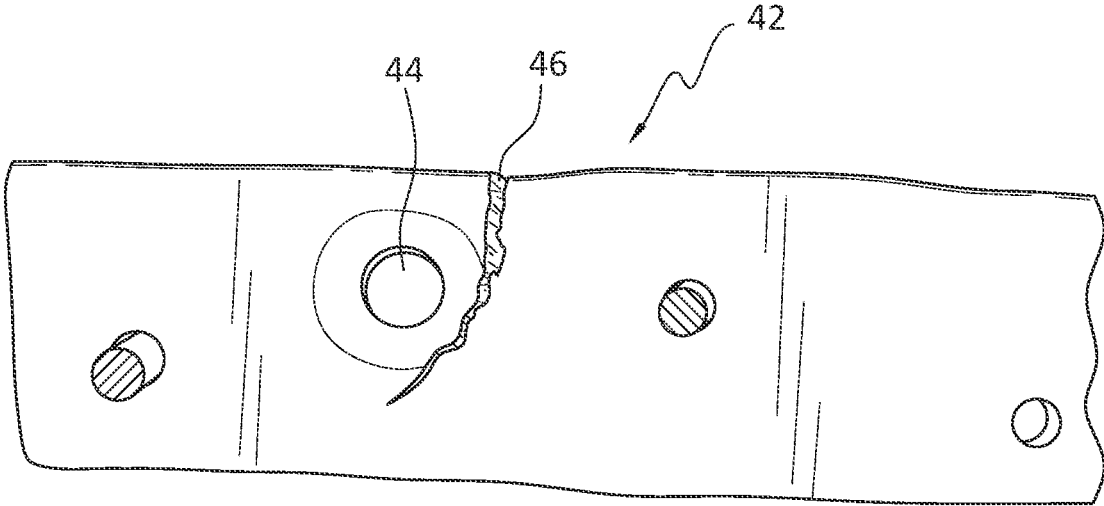
[0018] FIG. 3 is a photograph of an aft portion of a tail-cone reinforcement angle showing a typical failure in the horizontal stabilizer pivot shaft receiving bore of tail-cone reinforcement angle;

[0039] The horizontal stabilizer rear pivot hole receiving section 66 of the splice 54 is supplied, for its attachment to the blade 42 of the tail-cone reinforcement angle 50, without a horizontal stabilizer pivot shaft receiving bore, such as the one depicted at 44 in FIG. 3. This hole or bore 44 will be drilled into the aft section 66 of the splice 54, to align it with the corresponding aperture 40 in the tail-cone 44 in the aircraft's fuselage, once the splice 54 has been riveted and bolted in place, as will be discussed subsequently.

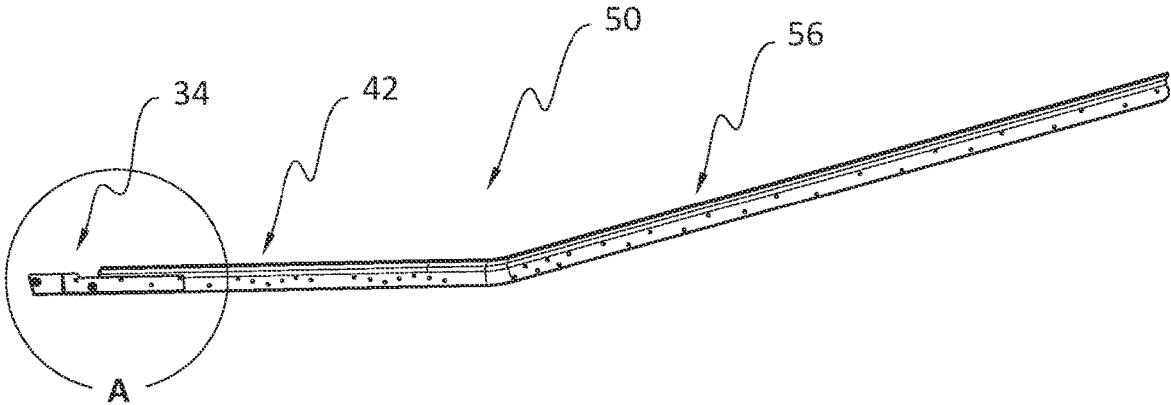
[0019] FIG. 4 is a perspective view of a left side tail-cone reinforcement angle including a left side tail-cone reinforcement angle splice, in accordance with the present invention;

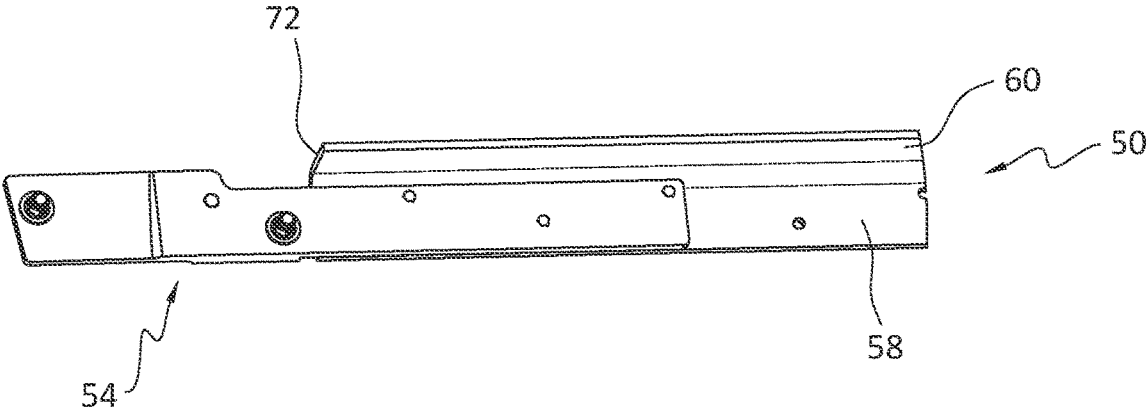
[0020] FIG. 5 is a side elevation view of an aft portion of the left side tail-cone reinforcement angle, encircled at A in FIG. 4, with the tail-cone reinforcement angle splice, in accordance with the present invention, in place;

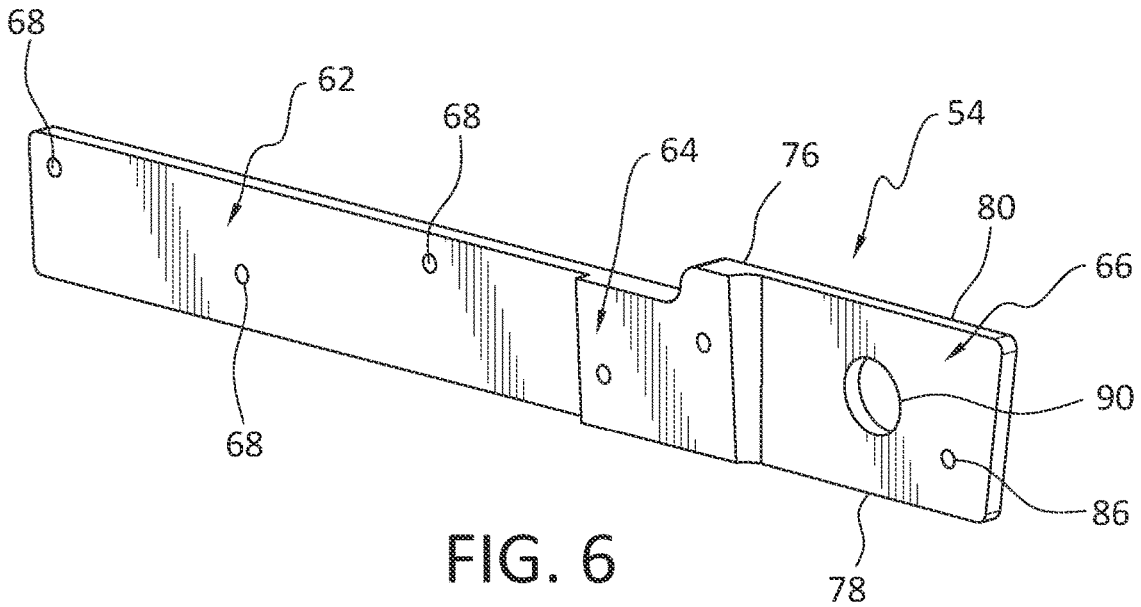
[0021] FIG. 6 is a perspective view of a left side tail-cone reinforcement angle splice prior to installation;

[0040] The aft section 66 of the splice 54 is generally planar, as may be seen in FIGS. 6 and 7. As may be seen particularly in FIG. 8, this aft section 66 is angled inwardly at approximately 2.44 degrees from its lower edge 78 to its upper edge 80. This slight inward angle is to accommodate the slight inward curve of the tail-cone section of the aircraft fuselage in the area of the horizontal stabilizer rear pivot shaft receiving aperture 40.

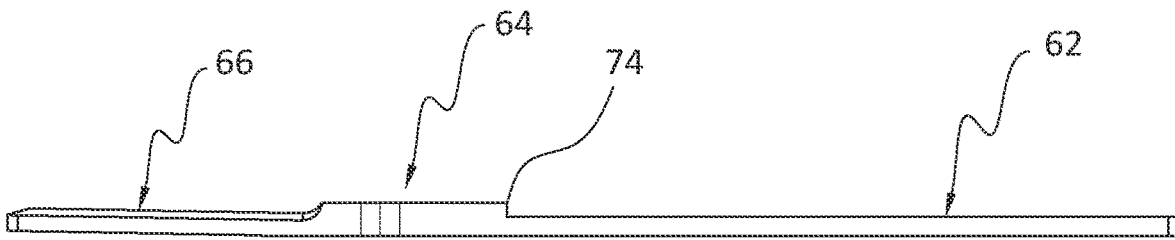
[0022] FIG. 7 is a top-plan view of the reinforcement angle splice depicted in FIG. 6;

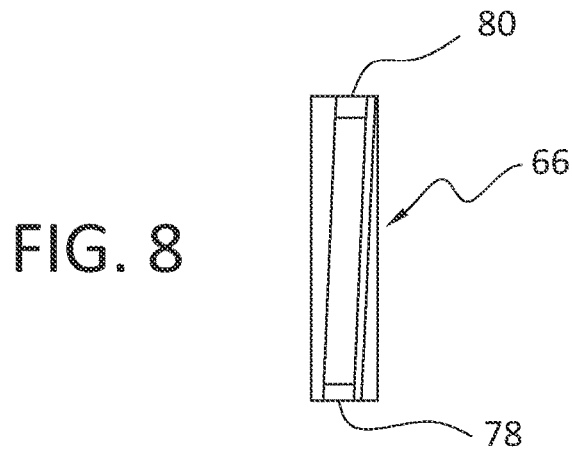
[0023] FIG. 8 is an aft end view of the reinforcement angle splice depicted in FIGS. 6 and 7 and taken from the right as seen in FIG. 6 and from the left as seen in FIG. 7;

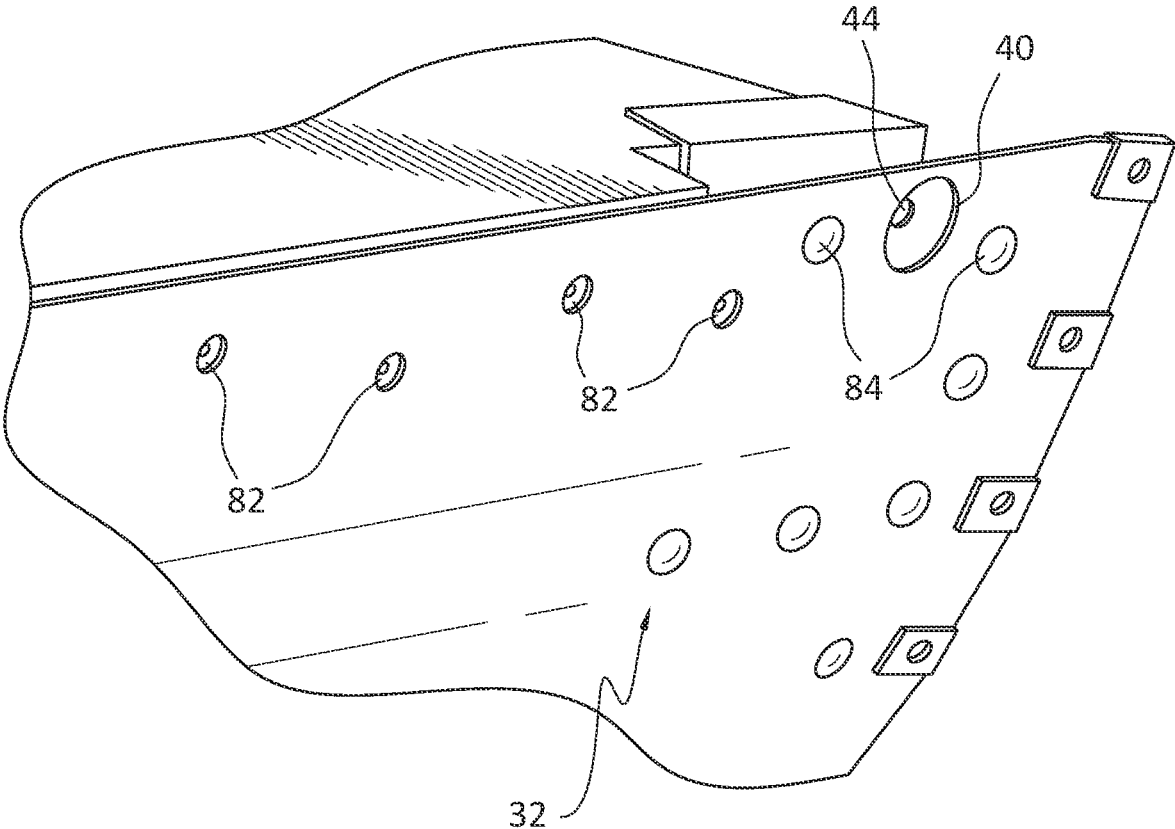
[0024] FIG. 9 is a view of an aft portion of the tail cone and showing the removal of four rivets;

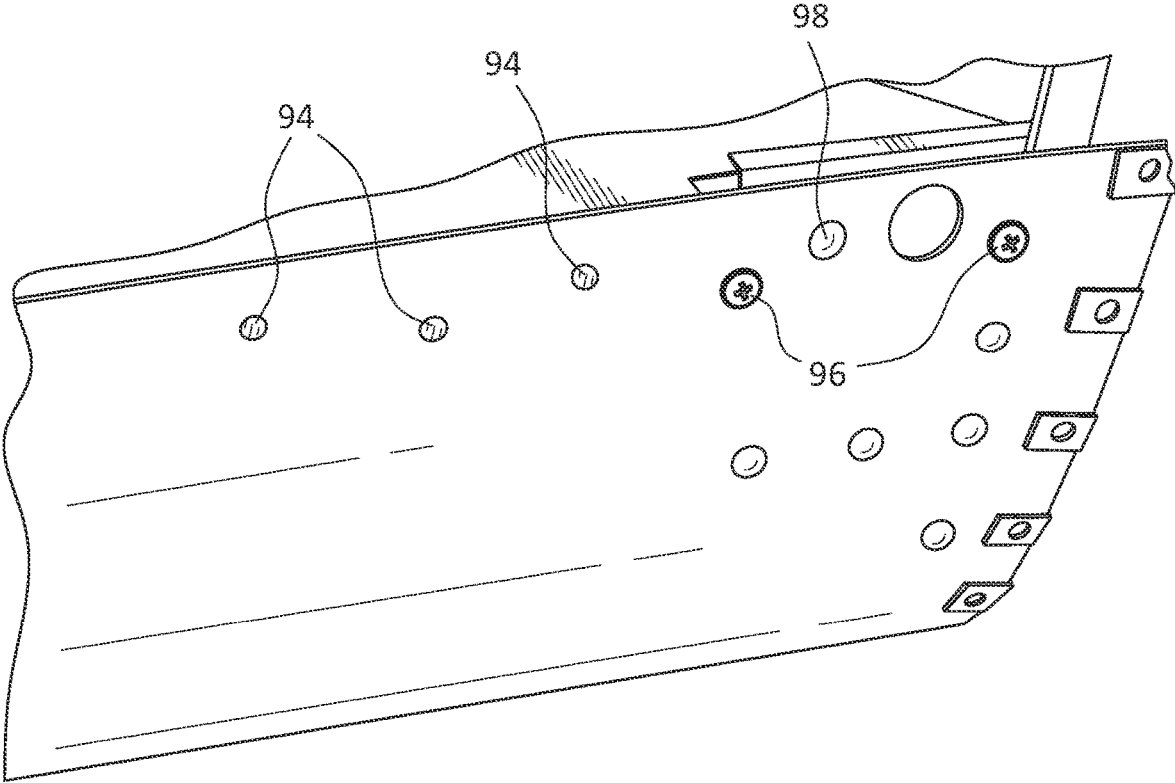
[0025] FIG. 10 is a view similar to FIG. 9 with the tail-cone reinforcement angle splice installed and secured in place;

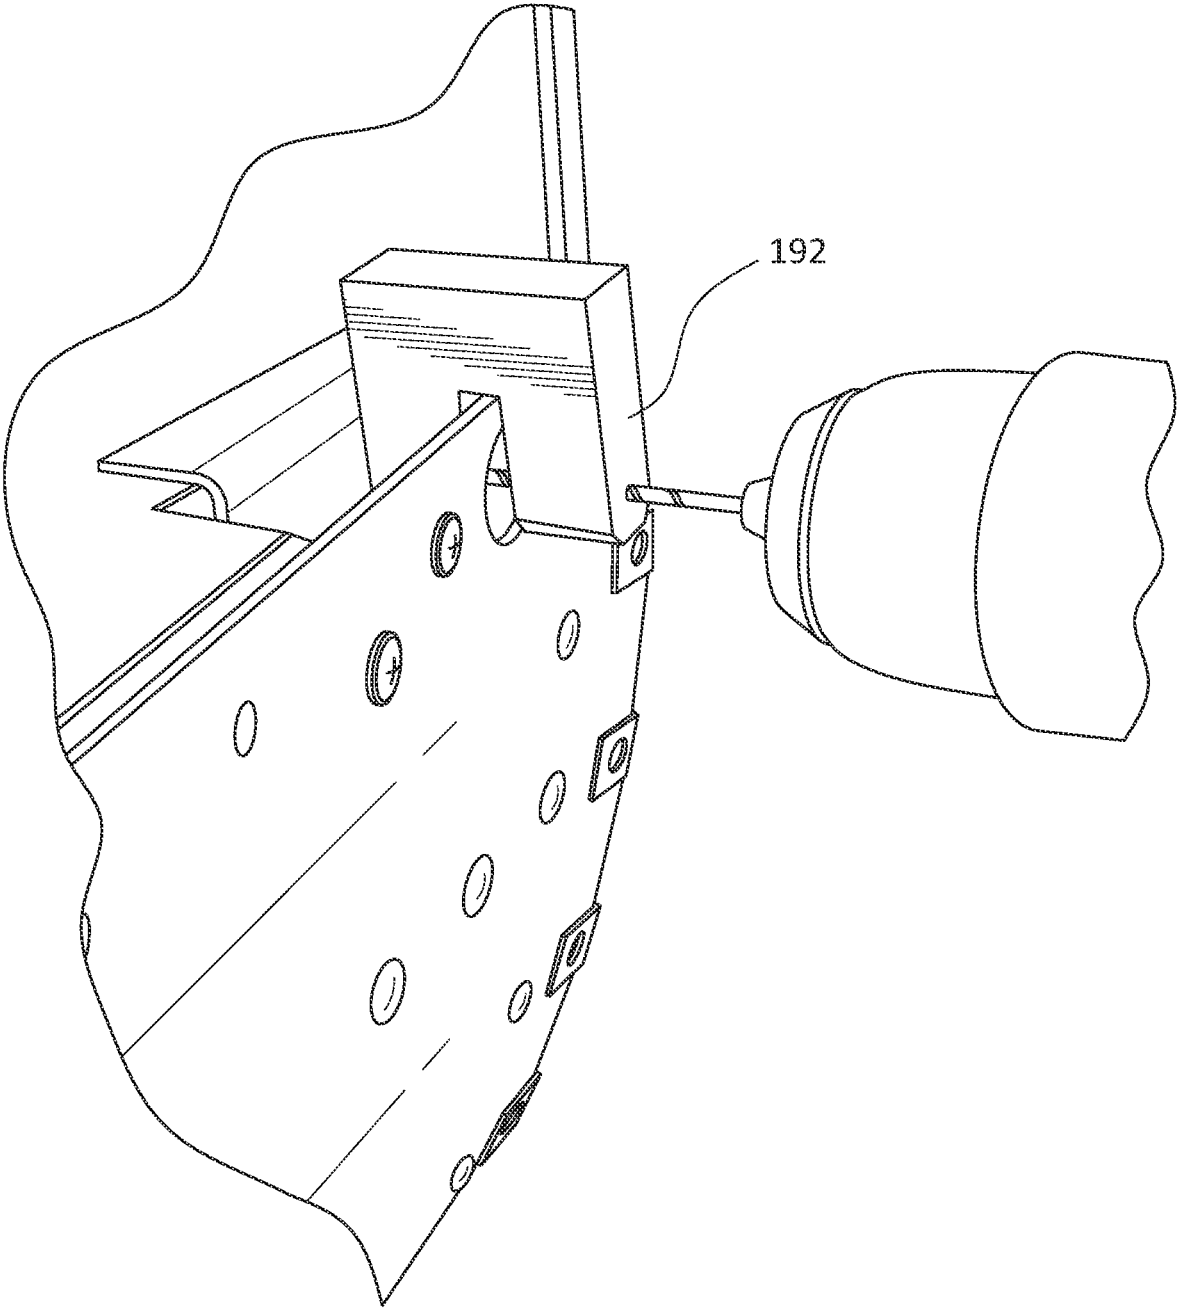
[0026] FIG. 11 is a view of the aft section of the tail cone and showing the forming of the horizontal stabilizer shaft receiving bore in the tail-cone reinforcement angle splice;

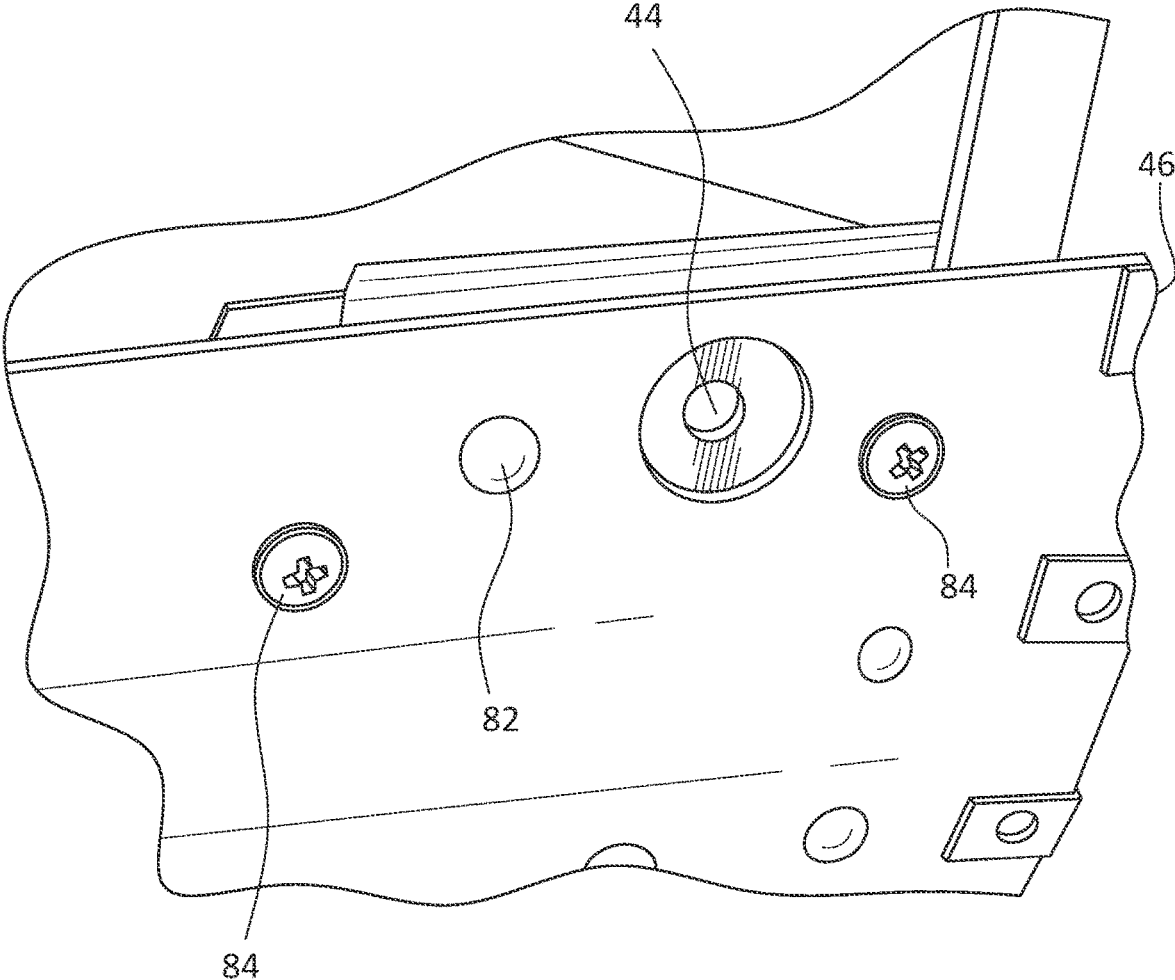
[0027] FIG. 12 is a view of the aft section of the tail cone and showing the completed horizontal stabilizer pivot shaft receiving bore formed in the tail-cone reinforcement angle splice; and
