(10) **Patent No.:** **US 11,260,986 B2**

(54) **METHOD AND DEVICE FOR INSPECTING THE DAMAGE TO THE SKIN OF AN AEROPLANE AFTER A LIGHTNING STRIKE**

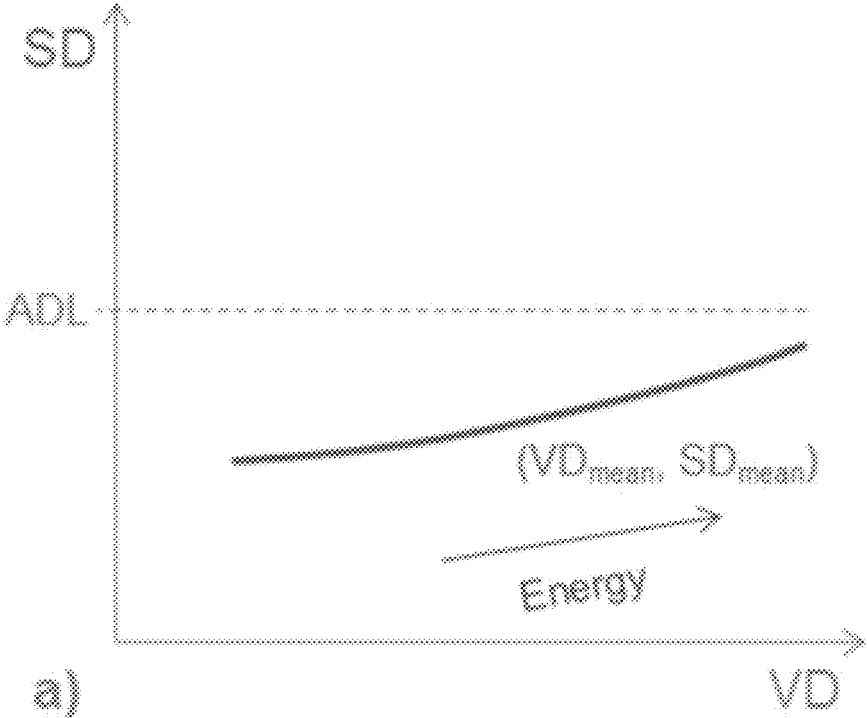
Fig. 1a

FIGS. 1a and 1b show graphics depicting the behavior of the Structural Damage (SD) and Visual Damage (VD) as the energy level of a lightning strike increases. FIG. 1a represents the case when the method called "Bounding-Box Approach" must be applied (maximum Structural Damage (SD) expected in that aircraft zone is less than the admissible Structural Damage (ADL)). FIG. 1b represents the alternative case, when the method called "Energy-Dependent Approach" must be used (maximum Structural Damage (SD) expected in that aircraft zone is greater than the admissible Structural Damage (ADL)).

As previously stated, this embodiment is valid for cases when the admissible Structural Damage (ADL) of the aircraft zone in which the mark is located is above the Structural Damage (SD) associated to the maximum lightning strike energy level or peak current expected on the aircraft section studied, see FIG. 1a.

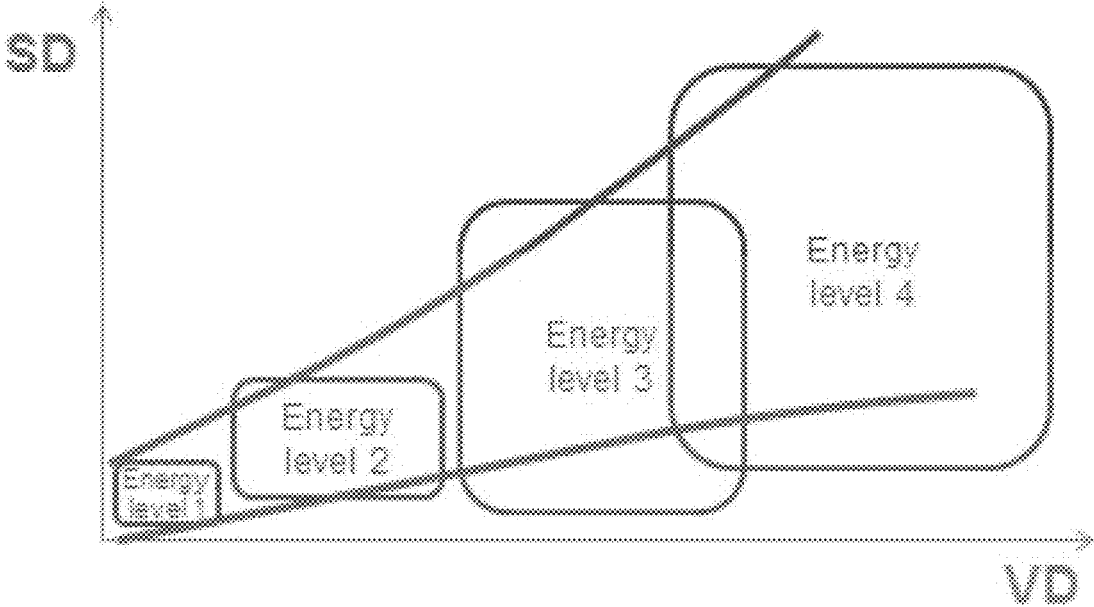
Fig. 2

FIG. 2 shows the two different approaches that can be used to find the Visual Damage-Structural Damage (VD-SD) relationship. The rectangles represent the "Bounding-Box Approach" while the other increasing lines represent the "Energy-Dependent Approach". "Energy level 1" is the least energetic and "energy level 4" is the most energetic.

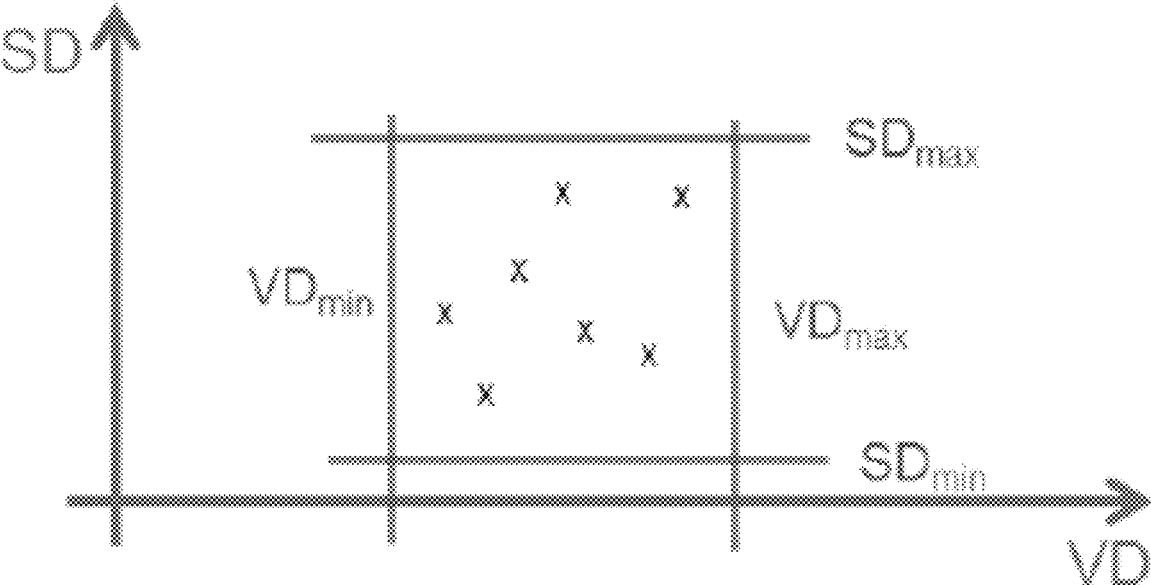
Fig. 3

FIG. 3 shows a qualitative representation of the "Bounding-Box Approach".

dently. The calculated limits define a "bounding-box" where the data is confined, see FIG. 3.

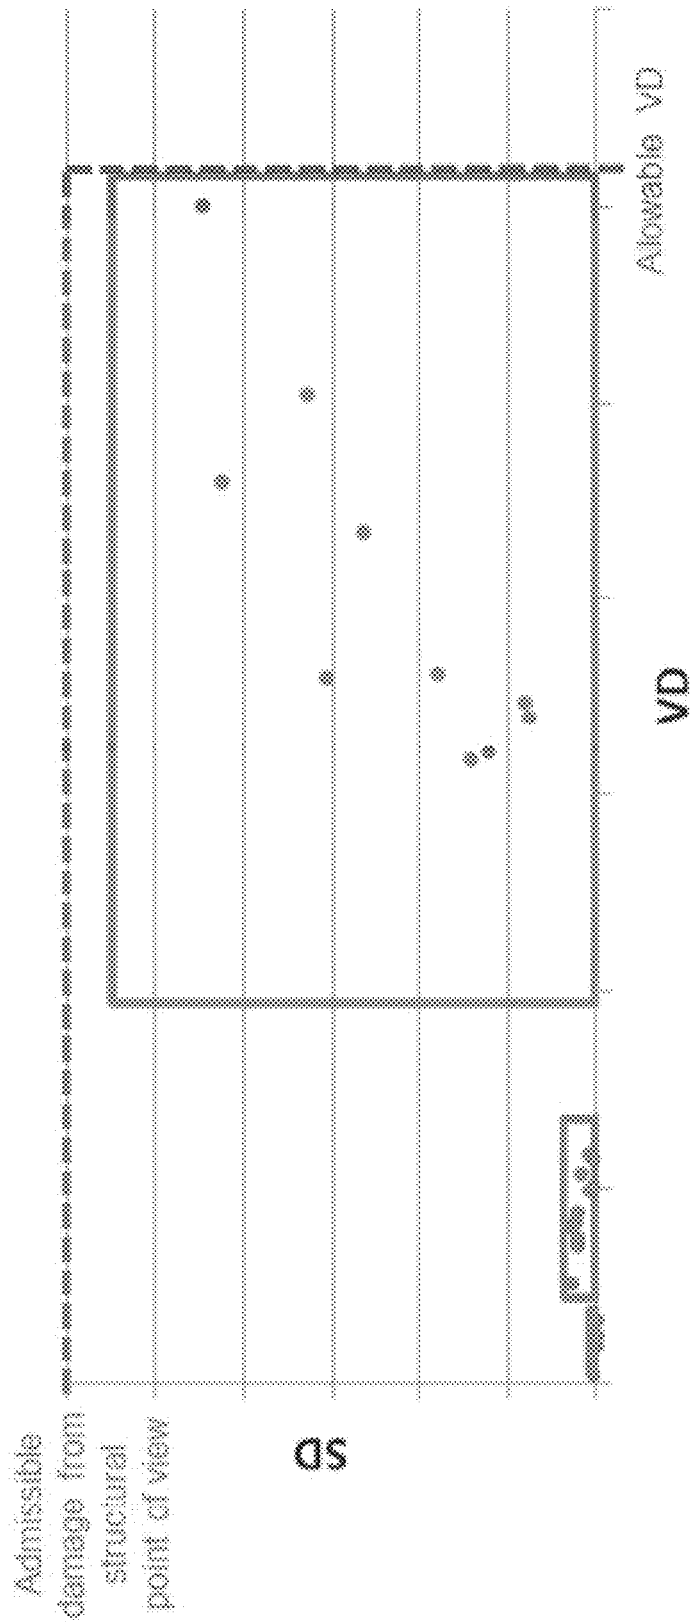
Fig. 4

To verify said calculation, it must be ensured that the admissible structural damage (ADL) of the mark is higher or equal than the upper limit of the bounding box, i.e., than the maximum Structural Damage ( $SD_{max}$ ). Hence, the admissible Visual Damage ( $VD_{ADL}$ ) corresponds to the righter-most limit of the box ( $VD_{max}$ ), see FIG. 4.

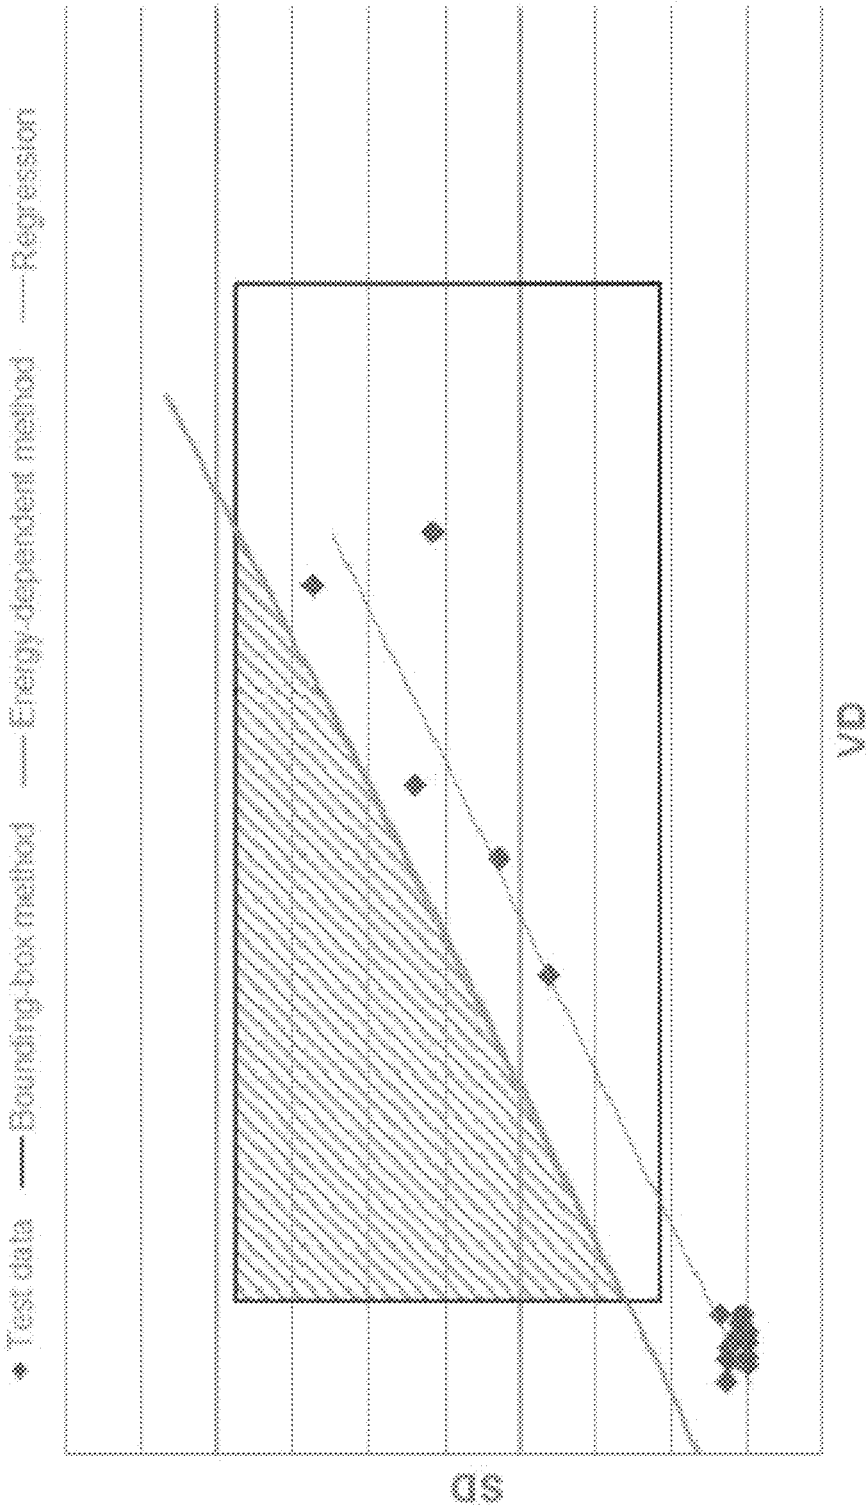
Fig. 5

FIG. 5 shows a graphic depicting a comparison of qualitative results when applying the "Bounding-Box Approach" and the "Energy-Dependent Approach".

When analyzing the Structural Damage (SD) and Visual Damage (VD) parameters independently (embodiment 1) the independent predicted intervals are higher because not all the available information is used. Taking into account that Structural Damage (SD) and Visual Damage (VD) follow a monotonically increasing relationship allows discarding some areas (VD, SD); hence, the prediction interval is more precise. In FIG. 5, a comparison of qualitative results when applying the bounding-box method and the energy-dependent method reveals a shaded area that corresponds to the area that can be discarded when using the energy-dependent method, which represents better the underlying physics.

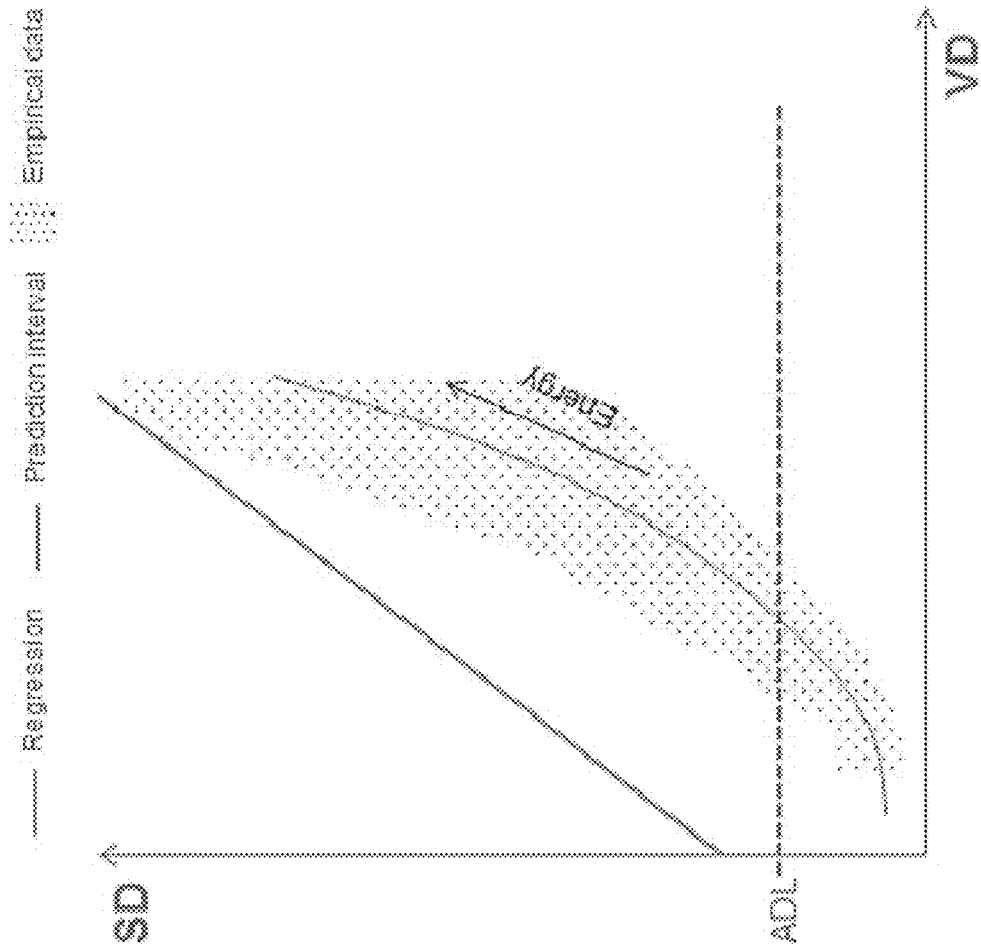
Fig. 6

FIG. 6 shows a graphic depicting the nature of the Visual Damage-Structural Damage (VD-SD) relationship and compares it to the statistical method used.

- Previous empirical data demonstrate that the Visual Damage-Structural Damage (VD-SD) relationship is clearly exponential, see FIG. 6; as the energy increases, Structural Damage (SD) increases exponentially as well as its dispersion. It would be possible to accurately define this behavior with an extensive lightning strike test campaign, but this option is not feasible as it would imply a considerable financial impact.

To overcome this issue, a mathematical model needs to be used to determine a prediction interval for the Structural Damage (SD). Unfortunately, there is no existing model able to adapt to an exponential curve with exponential increase of dispersion; standard models are driven by the Structural Damage (SD) scatter of the maximum energy level included in the calculations. As a result, extremely high values of Structural Damage (SD) are predicted for the lower energy levels, giving useless results from an applied technological perspective. This is clearly a fault of the mathematical model as empirical data show that the limit predicted by the standard models is excessively conservative, see FIG. 6.

- a. When calculating prediction intervals, due to the exponential increase of the scatter with the energy (see FIG. 6), when taking into account higher energy levels, the prediction interval is dominated by the Structural Damage-Visual Damage (SD-VD) values of the highest energy level. See FIG. 7a; when adding higher energy levels to the calculations ( $e_4 \rightarrow e_4 + e_3 \rightarrow e_4 + e_3 + e_2 \rightarrow e_4 + e_3 + e_2 + e_1$ ; being  $e_i$  different energy levels where  $e_4 < e_3 < e_2 < e_1$ ), the Structural Damage (SD) prediction curve (the maximum values of Structural Damage (SD) predicted for a Visual Damage (VD) range) is modified as it is strongly influenced by the higher energy level.

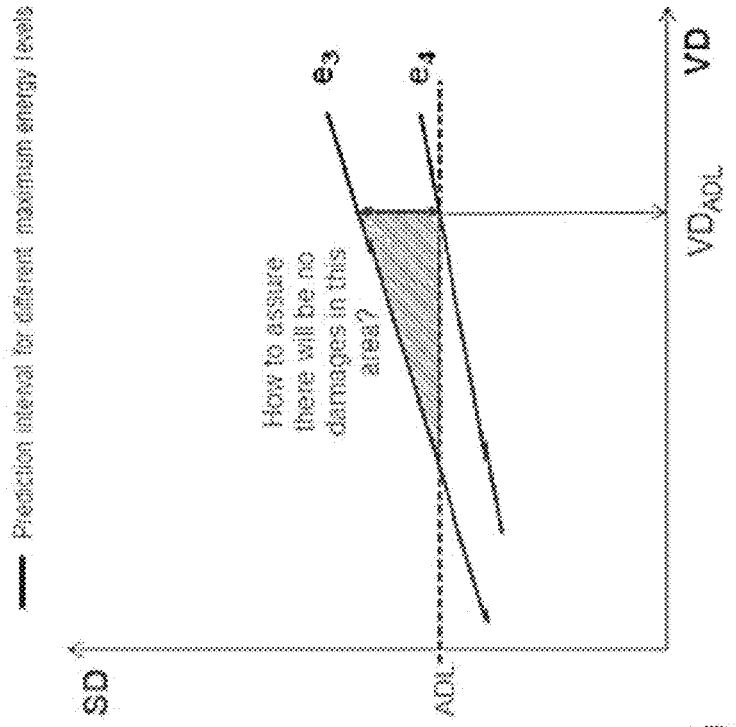
Fig. 7b

level expected on a specific zone of the aircraft in which the mark is located and  $e_a$  the lowest one. FIG. 7b highlights the possible problem of obtaining structural damages on areas which initially may thought to be safe due to the maximum energy level chosen.

As this method allows making estimations for lower energies, it must be assured that higher energy levels will not endanger the established allowable Visual Damage (VD): Structural Damages (SD) higher than the admissible structural damage (ADL) cannot be permitted for Visual Damages (VD) lower than the admissible Visual Damage ( $VD_{ADL}$ ), see FIG. 7b, as this situation could lead to a safety issue.

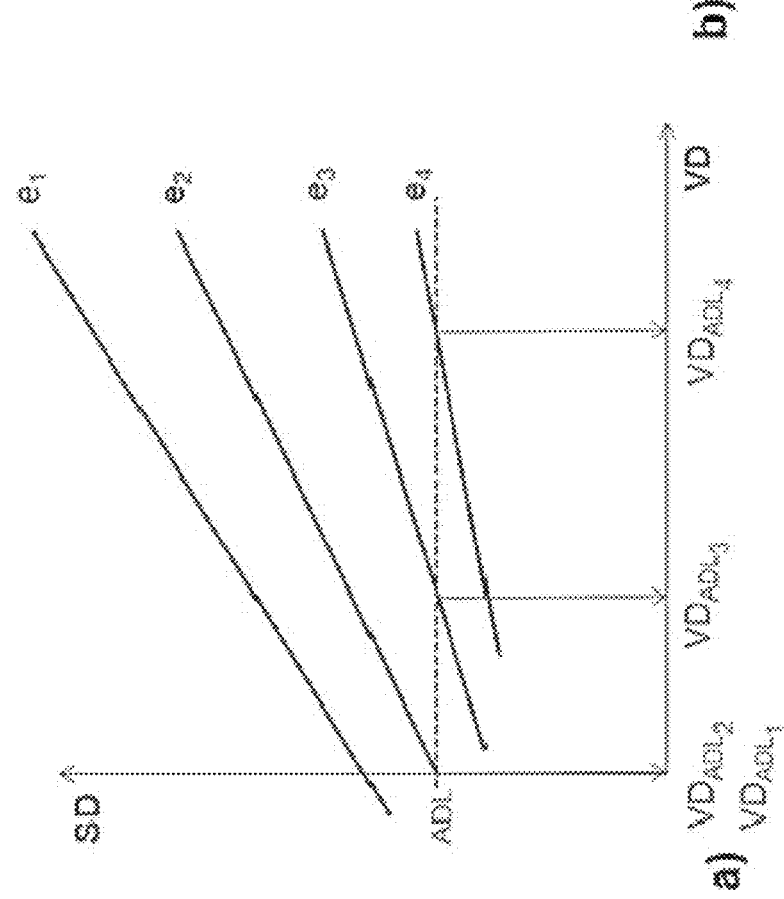
Fig. 7a

FIG. 7a shows graphics depicting the variation of Structural Damage (SD) prediction intervals with respect to the maximum energy level tested, being  $e_1$  the highest energy

- b. See FIG. 7a. For the  $e_1$  case, the prediction interval never intersects the admissible structural damage (ADL) line, hence, statistically, for any value of Visual Damage (VD), the Structural Damage (SD) obtained will be higher than the admissible structural damage (ADL).

- c. See FIG. 7a. For the  $e_3$  case (only energy levels  $e_3$  and  $e_a$  are taken into account) the prediction interval decreases as the scatter of damages associated to  $e_3$  is lower than the one associated to  $e_1$ . Hence, the prediction interval intersects the admissible structural damage (ADL) line, allowing to define an admissible Visual Damage ( $VD_{ADL3}$ ) that assures that for lower values of Visual Damages (VD), the Structural Damage (SD) will be lower than the admissible Structural Damage (ADL).

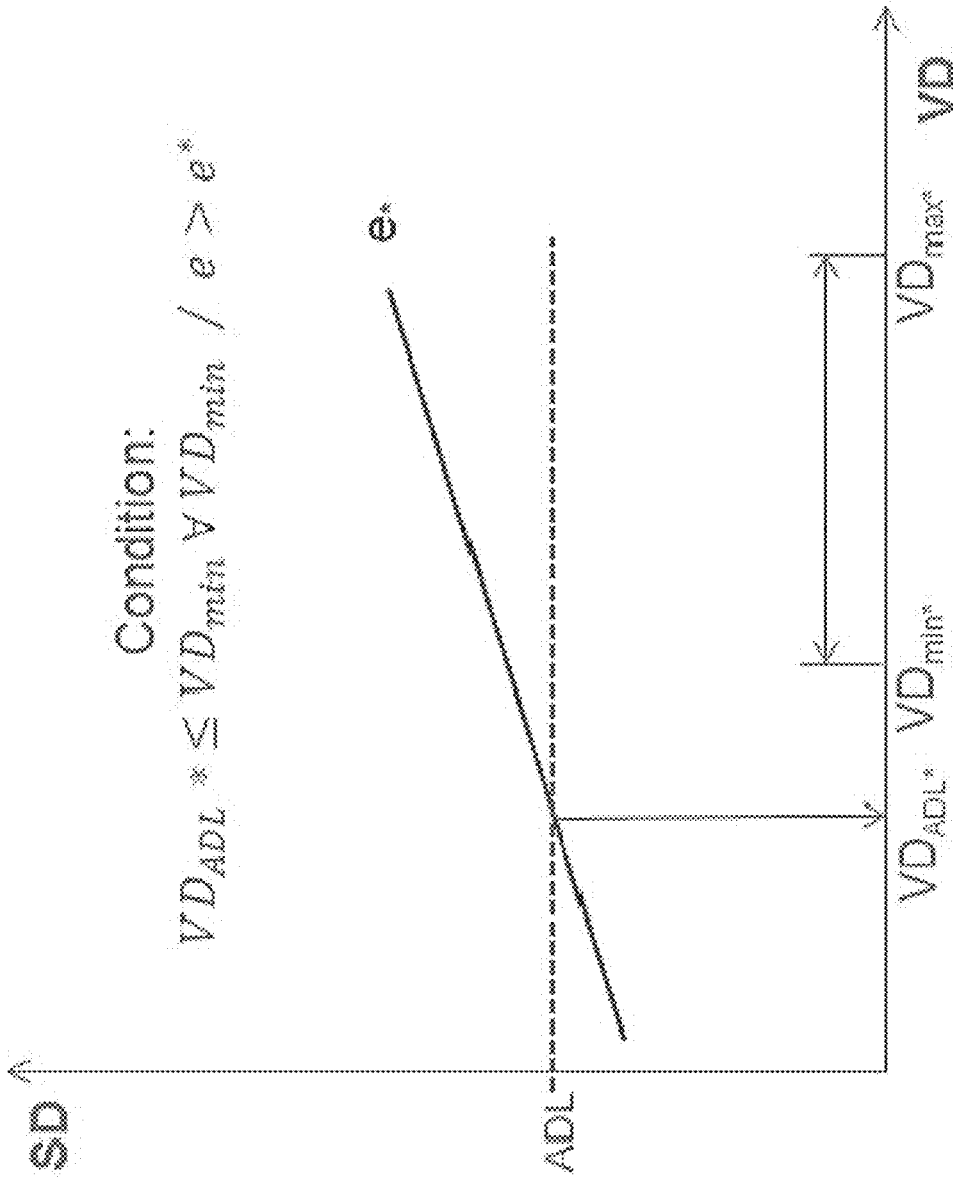
Fig. 8

FIG. 8 shows a graphic depicting the energy level for calculating the admissible Visual Damage ( $VD_{ADL}$ ), and the minimum and maximum Visual Damages ( $VD_{min}$ ,  $VD_{max}$ ) for said energy level.

- c. Hence, each energy level has an admissible Visual Damage ( $VD_{ADL}$ ) and minimum Visual Damage ( $VD_{min}$ ) associated to it. See FIG. 8.
- d. The admissible Visual Damage ( $VD_{ADL}$ ) corresponding to a specific energy level can be greater than the minimum Visual Damage ( $VD_{min}$ ) of higher energy levels, which implies that Structural Damage (SD) higher than the admissible Structural Damage (ADL) could be found for Visual Damage (VD) lower than admissible Visual Damage ( $VD_{ADL}$ ). See FIG. 7b. Contrary to admissible Visual Damage ( $VD_{ADL}$ ), minimum Visual Damage ( $VD_{min}$ ) does not always follow a monotonically increasing relationship with the energy (see FIG. 9), reason why this circumstance can occur.

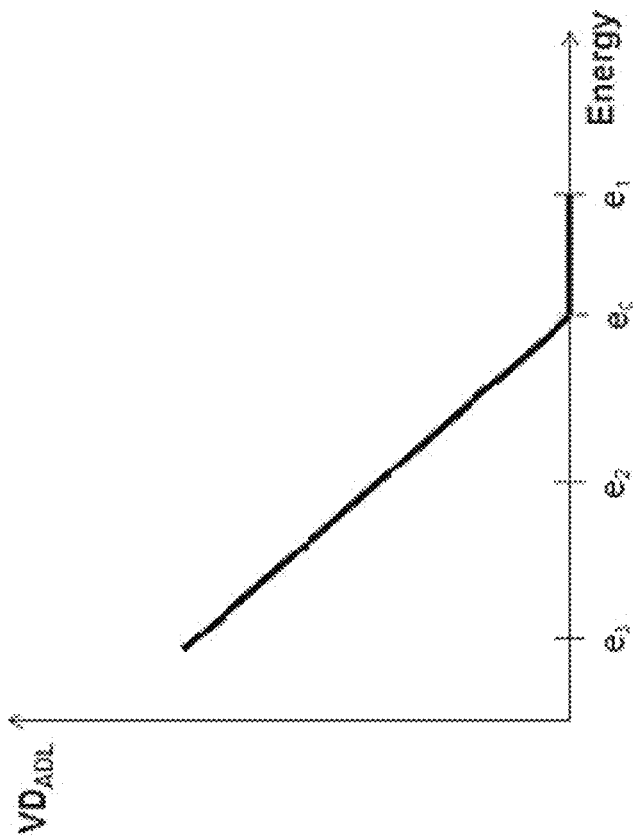
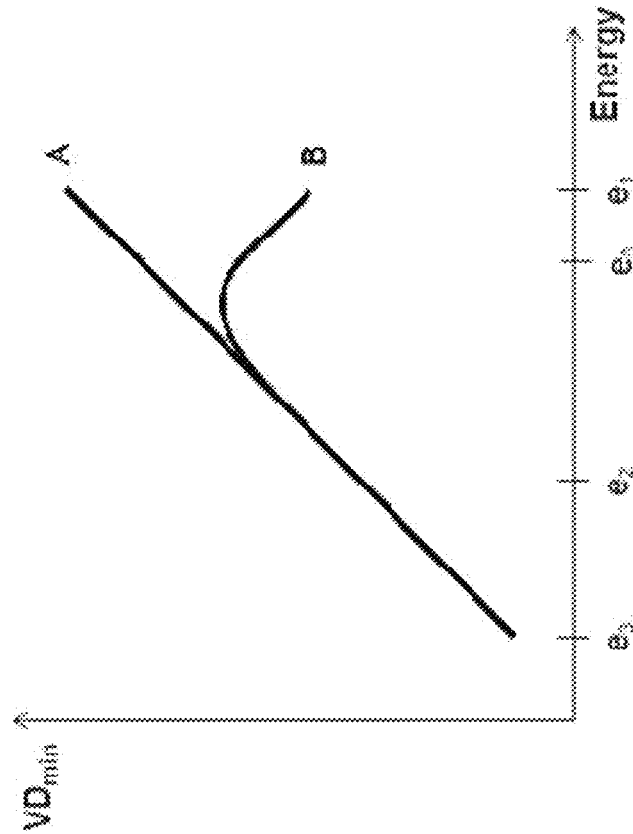
Fig. 9b

FIGS. 9a and 9b show graphics depicting the relationships admissible Visual Damage-energy ( $VD_{ADL}$ -energy) and minimum Visual Damage-energy ( $VD_{min}$ -energy), respectively. In FIG. 9b, the curve A represents the case when minimum Visual Damage ( $VD_{min}$ ) is monotonically increasing with the energy, while curve B represents the case when it is not.

It is possible to set the relationship between admissible Visual Damage ( $VD_{ADL}$ ) and the energy level  $e$ , as well as between the minimum Visual Damage ( $VD_{min}$ ) and the energy level  $e$ , see FIG. 9. The admissible Visual Damage ( $VD_{ADL}$ ) follows a monotonically decreasing function. The minimum Visual Damage ( $VD_{min}$ ) follows a monotonically increasing relationship with the energy  $e$ , up to an energy level where, depending on several parameters, it may or may not continue following a monotonically increasing relationship.

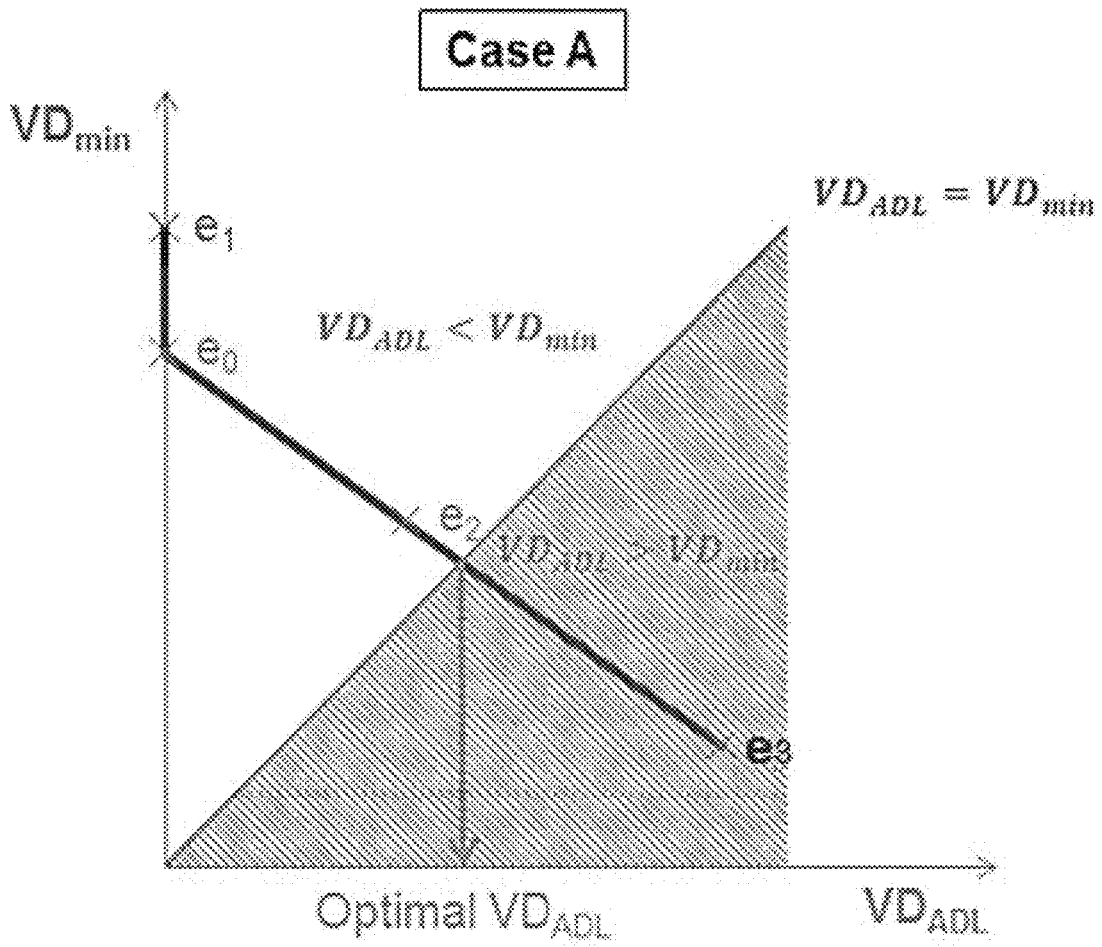
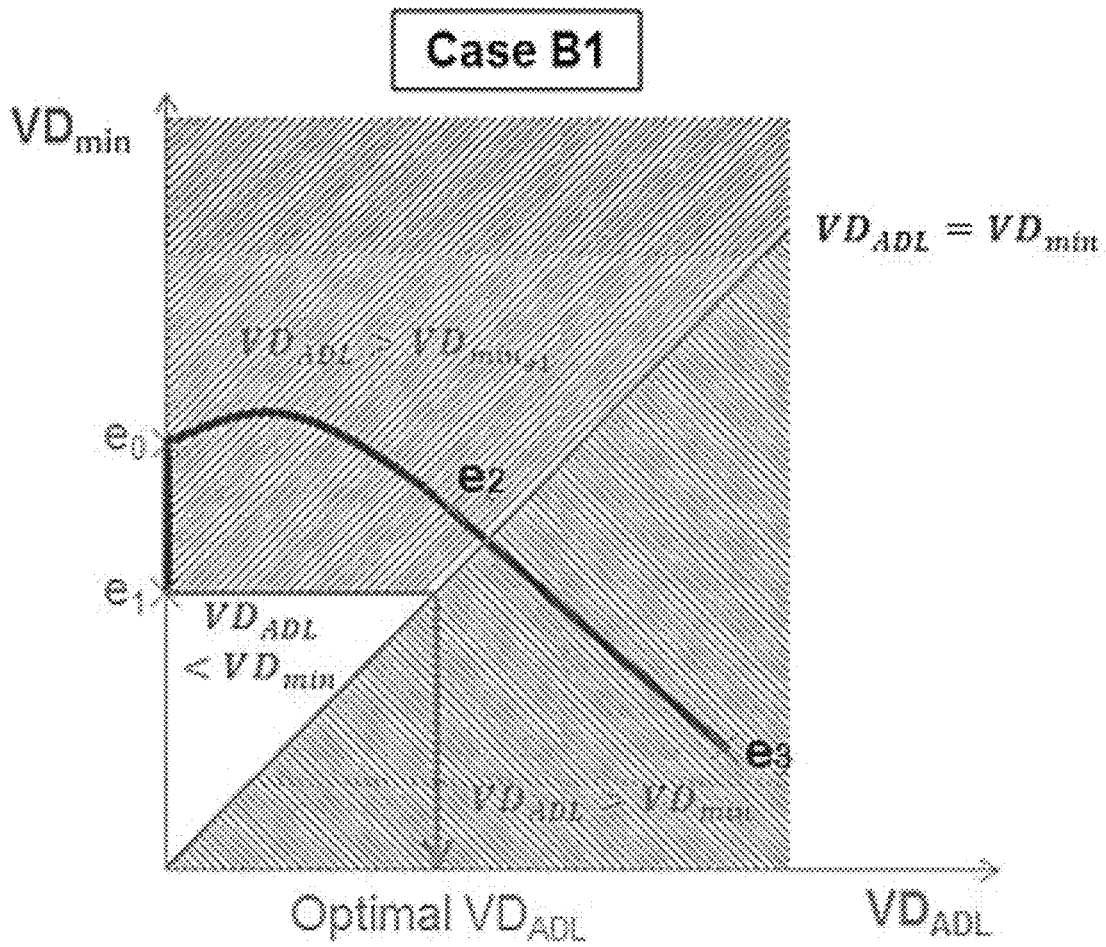
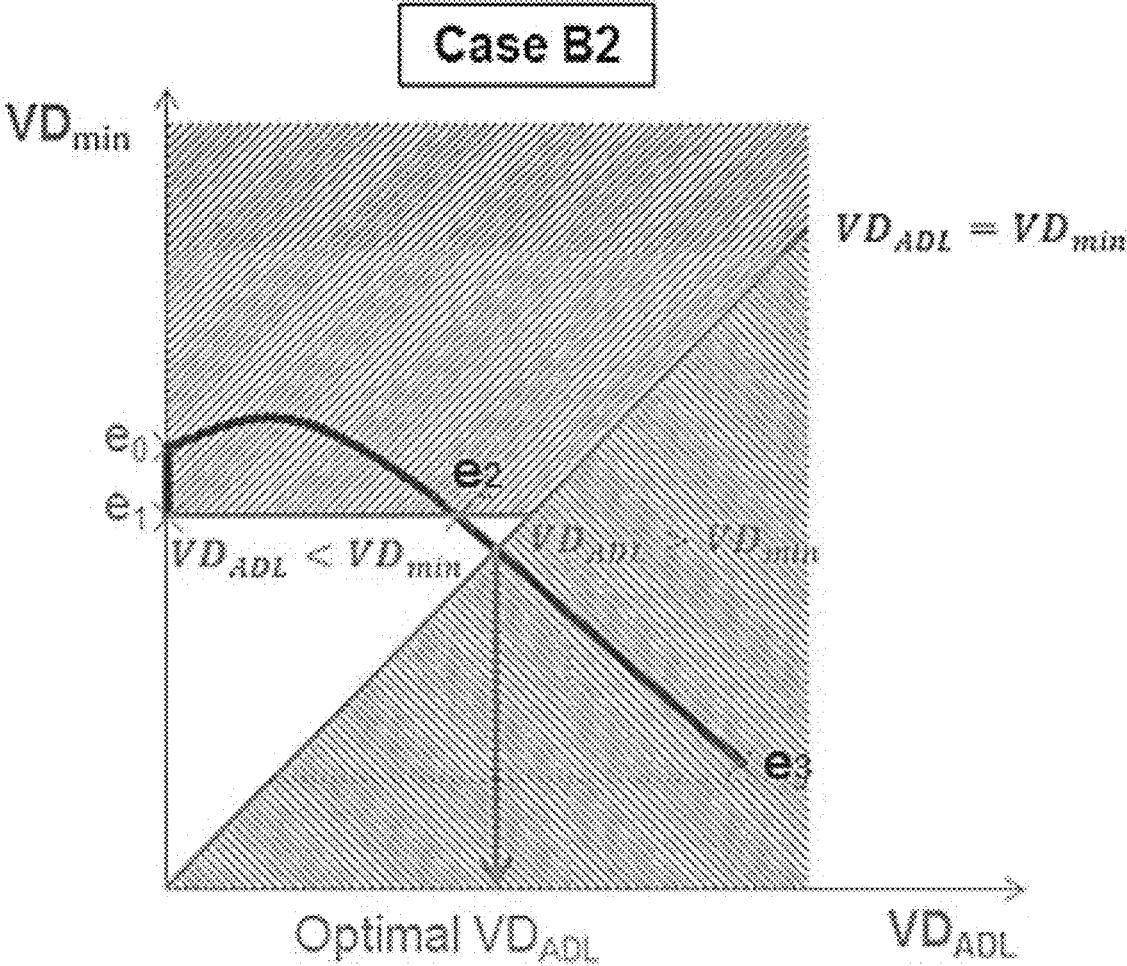
**Fig. 10A**

FIGS. 10A to 10C shows three graphics depicting minimum Visual Damage-admissible Visual Damage ( $VD_{min}$ - $VD_{ADL}$ ) relationship. If the minimum Visual Damage ( $VD_{min}$ ) monotonically increases with the energy level, case A is applicable; if the minimum Visual Damage ( $VD_{min}$ ) does not monotonically increase with the energy, case B1 and B2 are applicable.

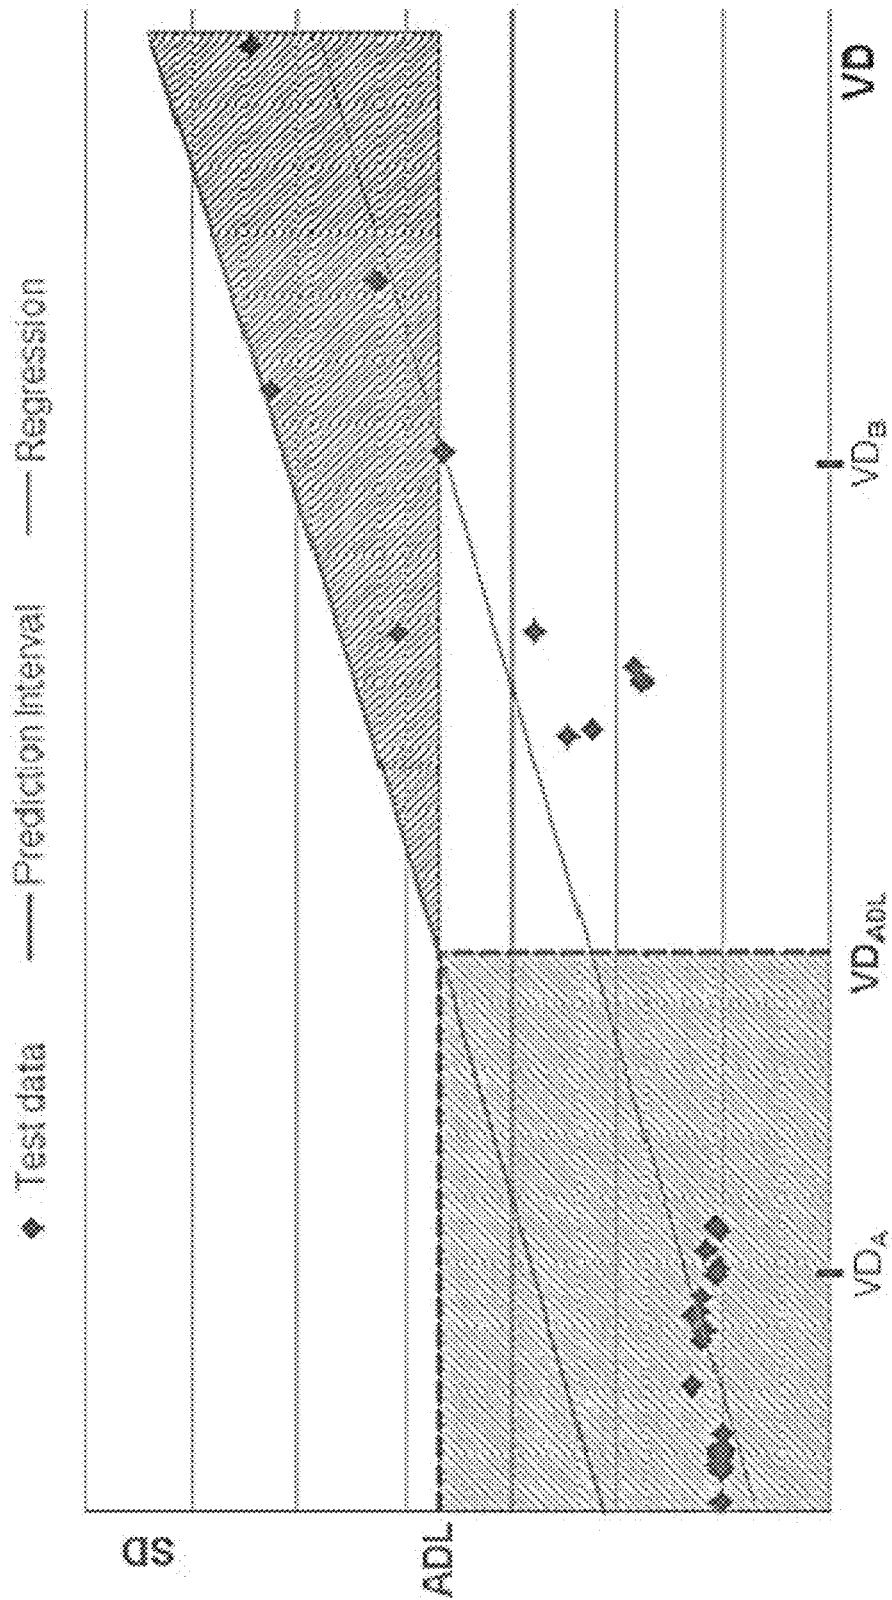
Fig. 11

FIG. 11 shows a graphic depicting the relationship Structural Damage-Visual Damage ( $SD$ - $VD$ ) found using the method called "Energy-Dependent Approach".
